# **REPORT TO CONGRESS: COASTAL BARRIER RESOURCES SYSTEM**

**Shoreline Change and Wetland Loss in the  
Coastal Barrier Resources System:  
A Case Study Analysis**

SHORELINE CHANGE AND WETLAND LOSS IN THE COASTAL BARRIER  
RESOURCES SYSTEM: A CASE STUDY ANALYSIS

1988

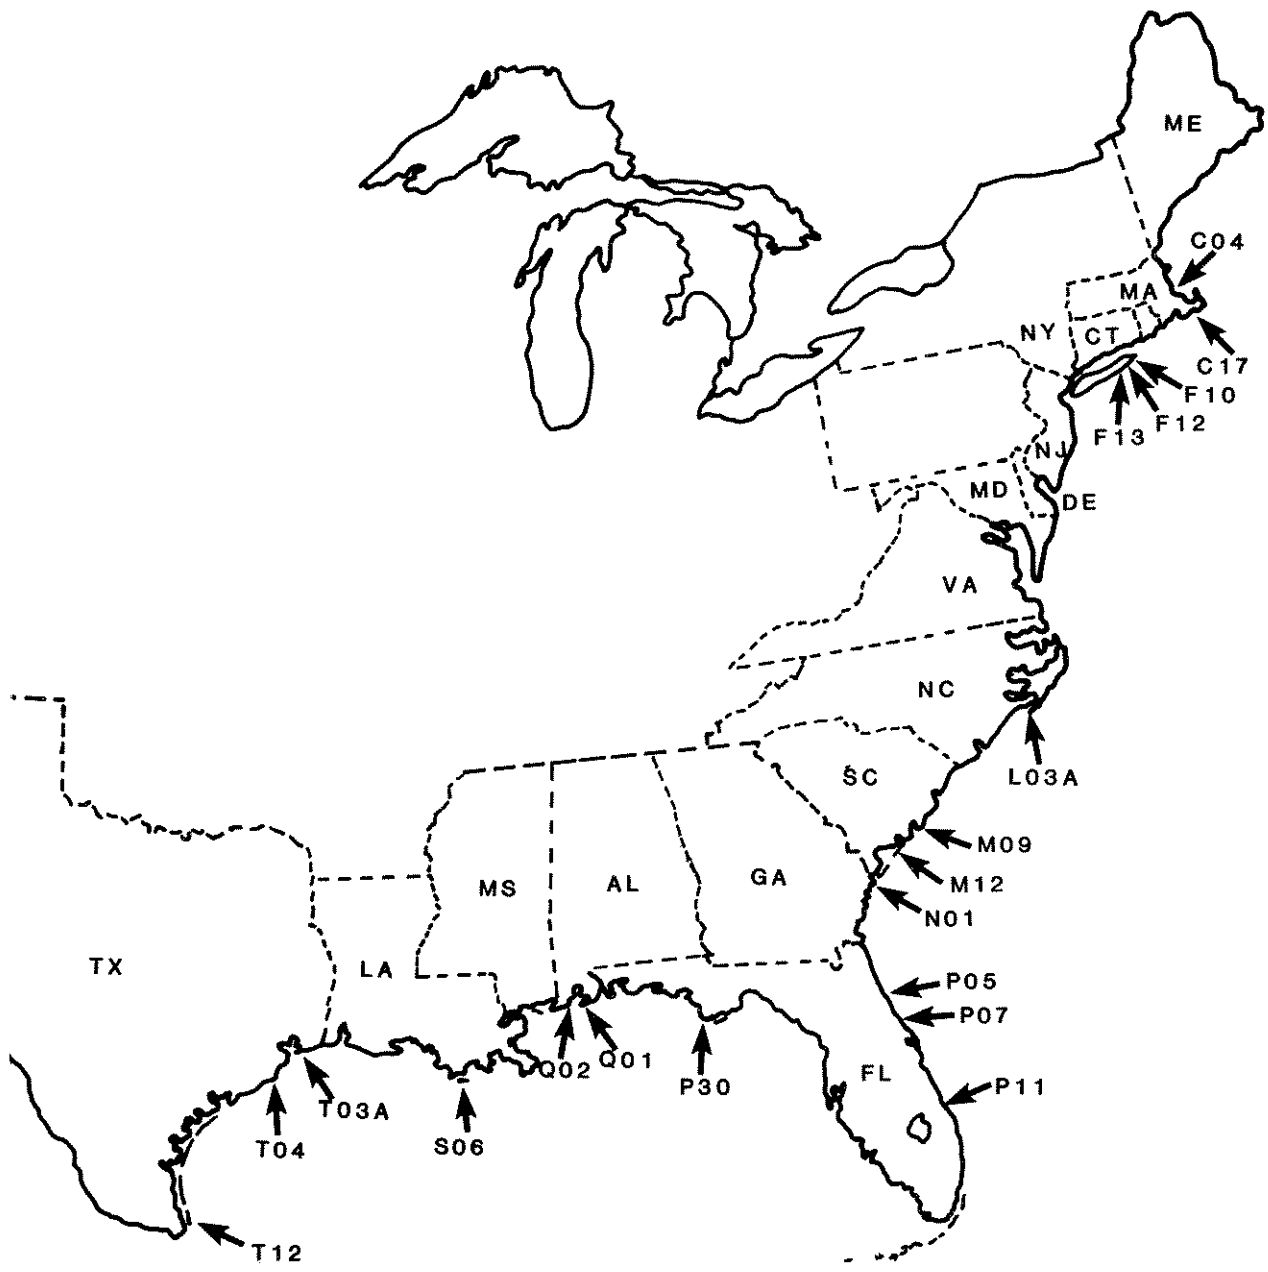
Figure 2. Location of the 19 case study CBRS units.

Case studies of the 18 coastal barriers (19 CBRS units) that were selected follow, starting with Plymouth Bay, Massachusetts, and working down the Atlantic coast and around the gulf coast to Boca Chica, Texas (Figure 2). These case studies contain regional and site-specific information about the physical characteristics of the 18 coastal barriers. We do not discuss general characteristics of all barriers. General information about types of coastal barriers, waves, tides, sea-level rise, storm impacts, sediment sources, and the like is presented in Chapter 2, Volume 1 of this CBRS report. Those readers who are not familiar with these topics may wish to read that chapter before these case studies.

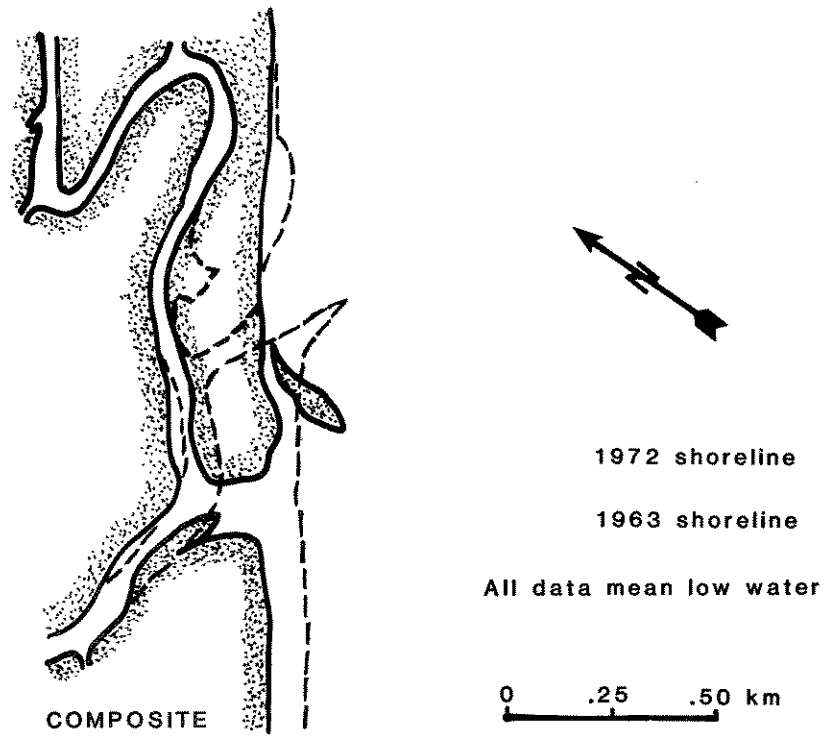
Figure 18. Shoreline changes around Frampton Inlet, 1963-72 (modified from Hulse and Kanes 1972).

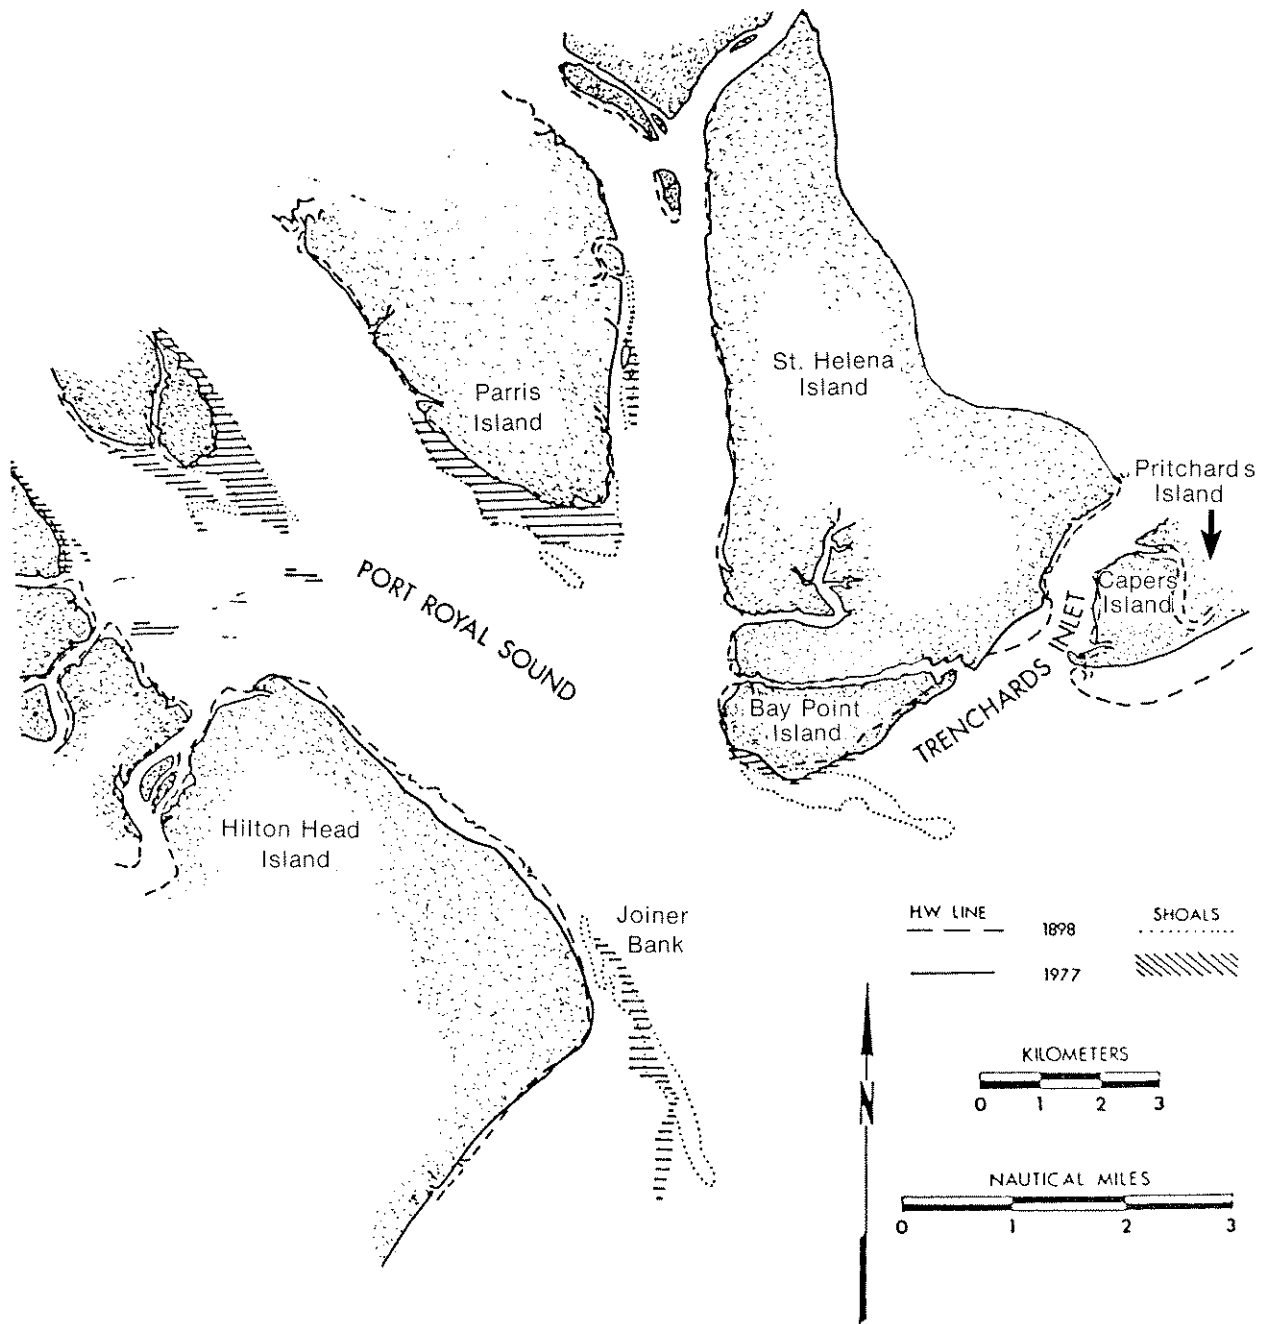
Figure 21. Recent shoreline changes for Port Royal Sound (Zarillo et al. 1984).

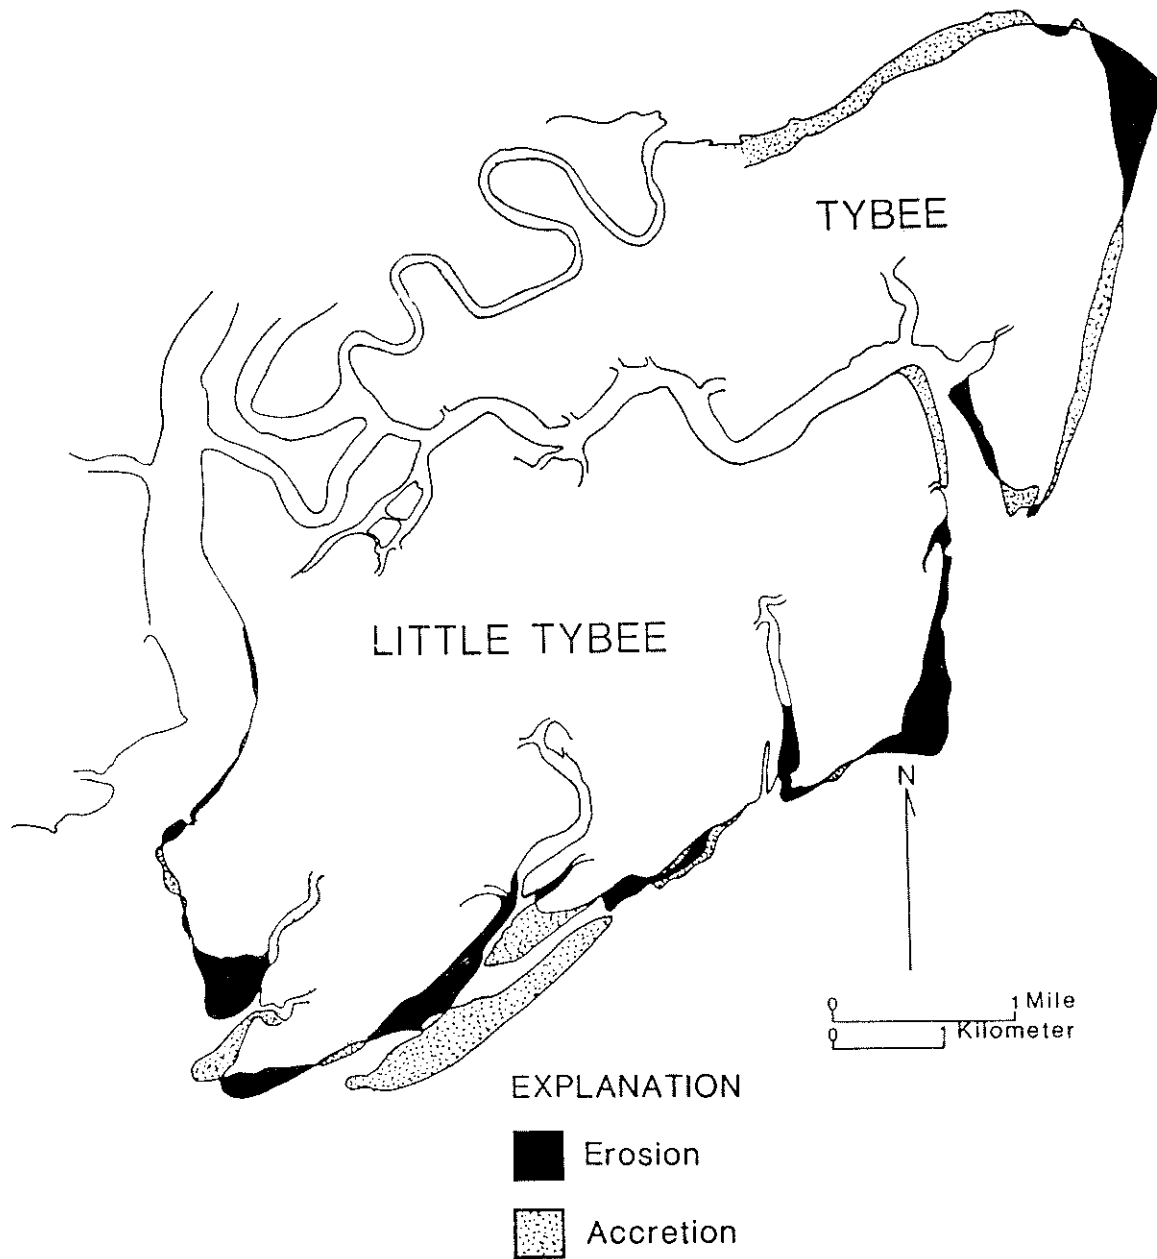
Figure 26. Net shoreline changes on Tybee and Little Tybee Islands, 1866-1974 (Griffin and Henry 1983).

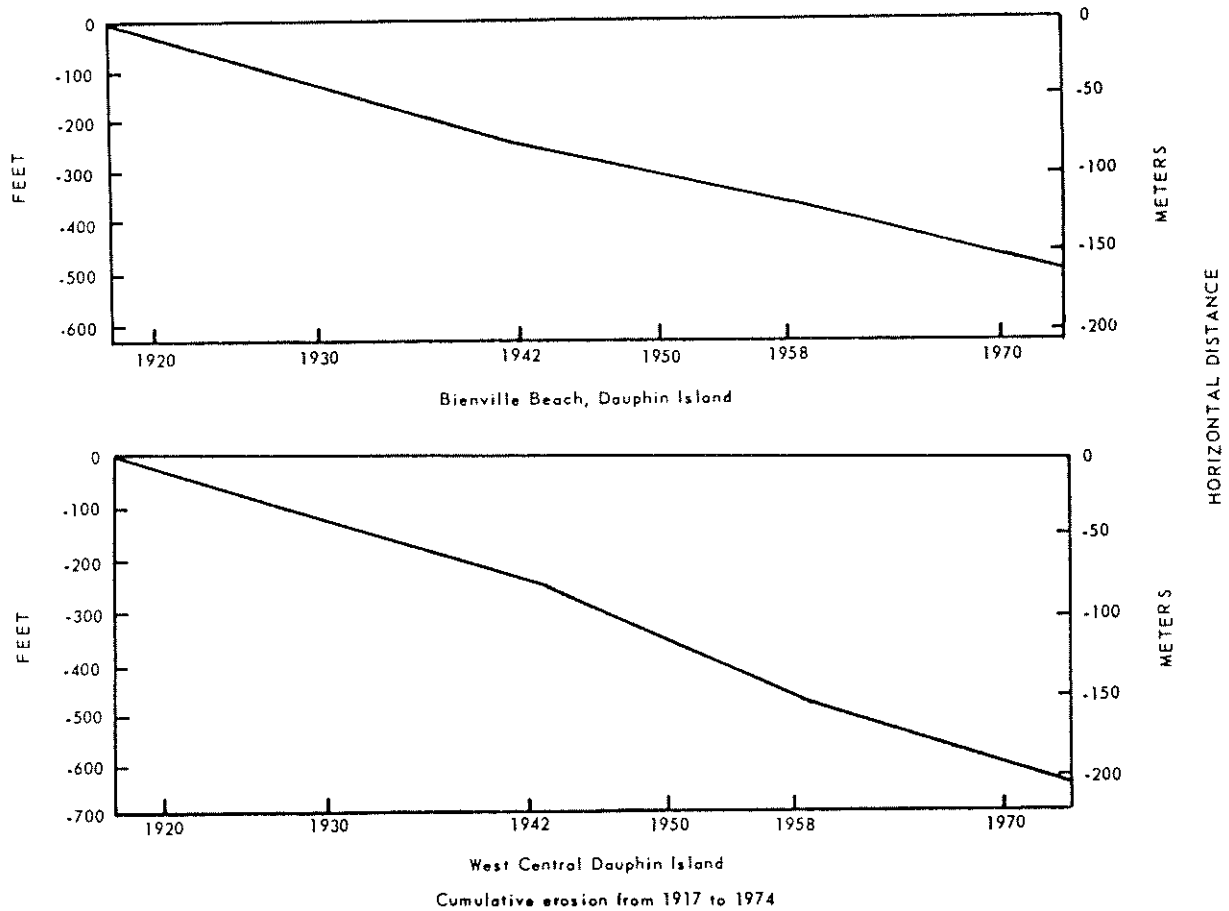
Figure 43. Cumulative erosion along Bienville Beach and west-central Dauphin Island, 1917-74 (Hardin et al. 1976).
