## RESTORATION

# Hydrologic Restoration of Peat Soils on Great Dismal Swamp National Wildlife Refuge

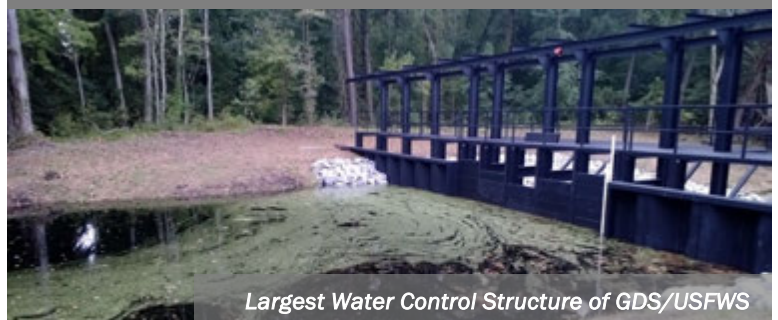
Largest Water Control Structure of GDS/USFWS

**Rewetting the Peat:** Refuge staff installed, replaced, or repaired water control structures in existing ditches to reduce drainage and raise the water table in neighboring peat soils. The structures increased the distance that water travels as it leaks out of the swamp by directing it away from main canals. This increases the time peat soil is wet, increasing its water-storage capacity and subsequently minimizing flooding and reducing habitat and soil loss from fire damage. Since 2014, surface and groundwater levels have been raised by 0.5 to 1 ft in the swamp.
