Mackay Island NWR Marsh Loss Information

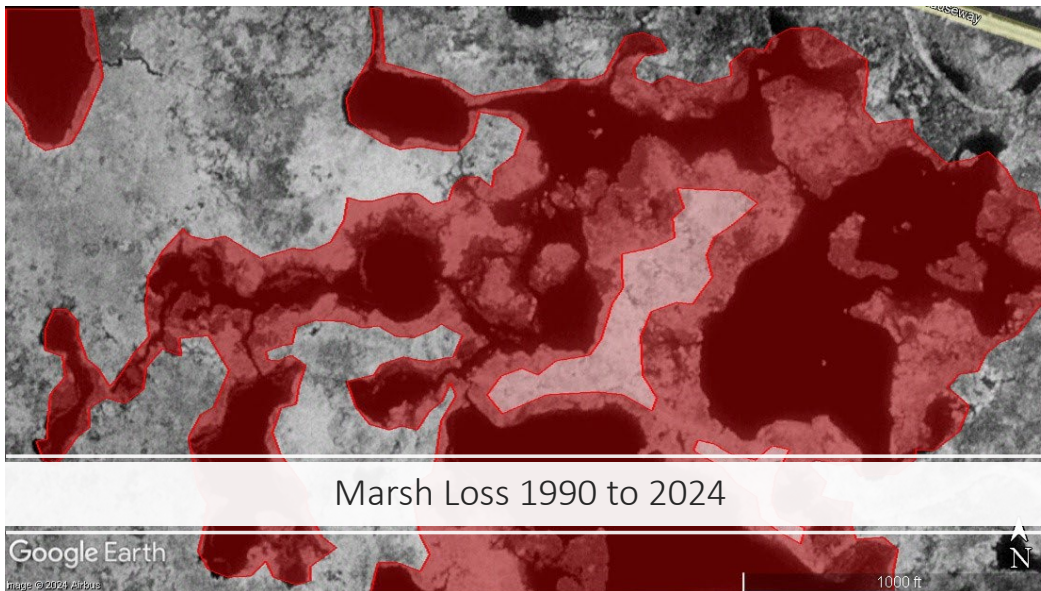
Figure 2. Marsh Loss within the Great Marsh: The area covered in red shows the marshes lost from 1990 to 2024 in a small section of the Great Marsh along the causeway. Marsh loss rates in the interior portions of the marsh are accelerating.

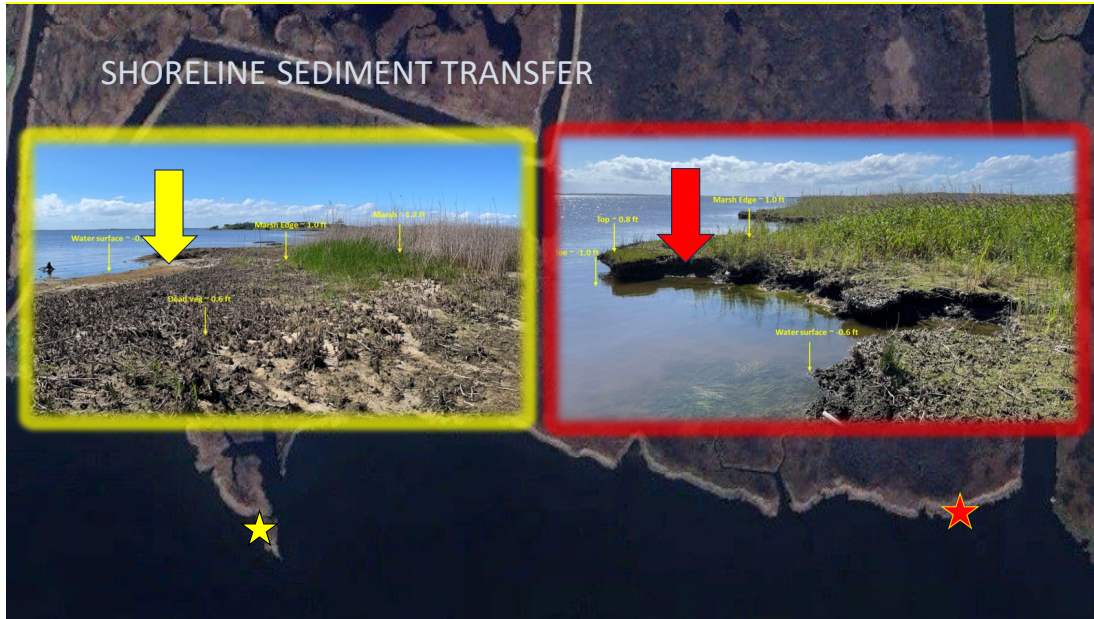
Figure 4. Shoreline Sediment Transfer. Shoreline sediment deposited 1,300 yards west of Corey's ditch (Yellow Arrow) showing a gradual shoreline. No shoreline sediment being deposited near the mouth of Corey's ditch (Red Arrow) showing a vertical shoreline.

Natural sediment transfer can maintain and build shorelines as well as repair and build natural marshes, but manmade structures can impede these natural forces.

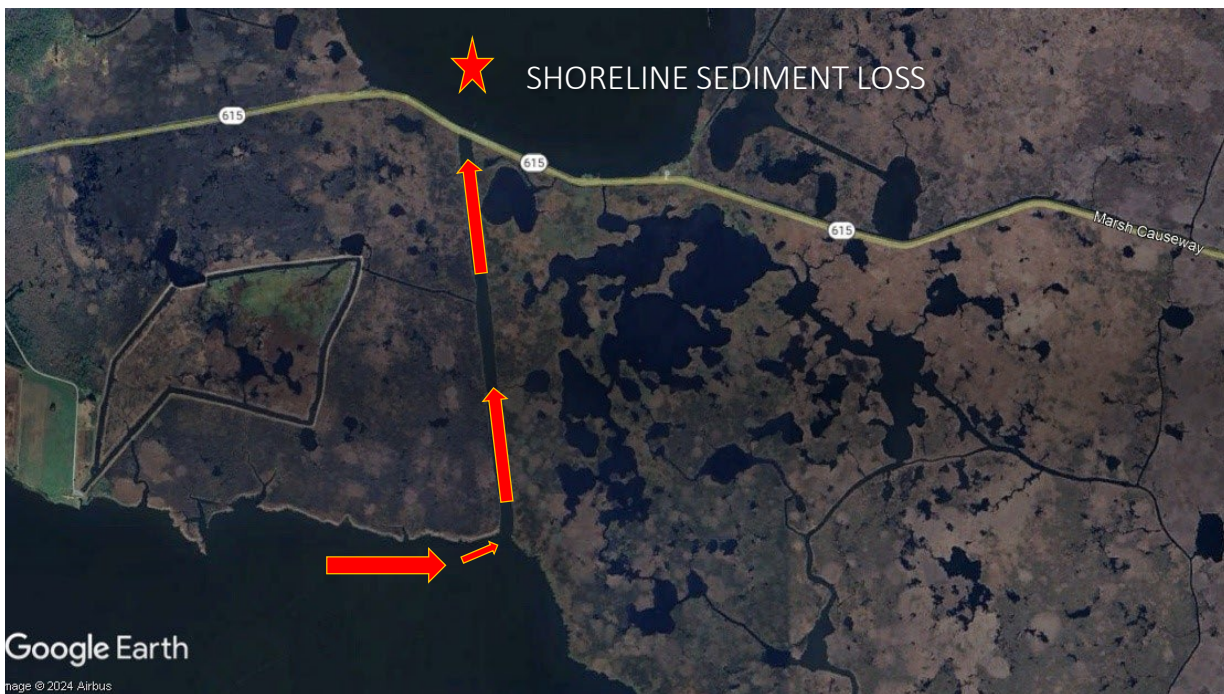
Figure 5. Shoreline Sediment Loss from south shore of Great Marsh. Due in part to the high water velocities within Corey's ditch, sediments are being deposited north of the bridge into Barley's Bay. Note: During low water events you can see the sediment deposits in Barley's Bay when looking north of the bridge.

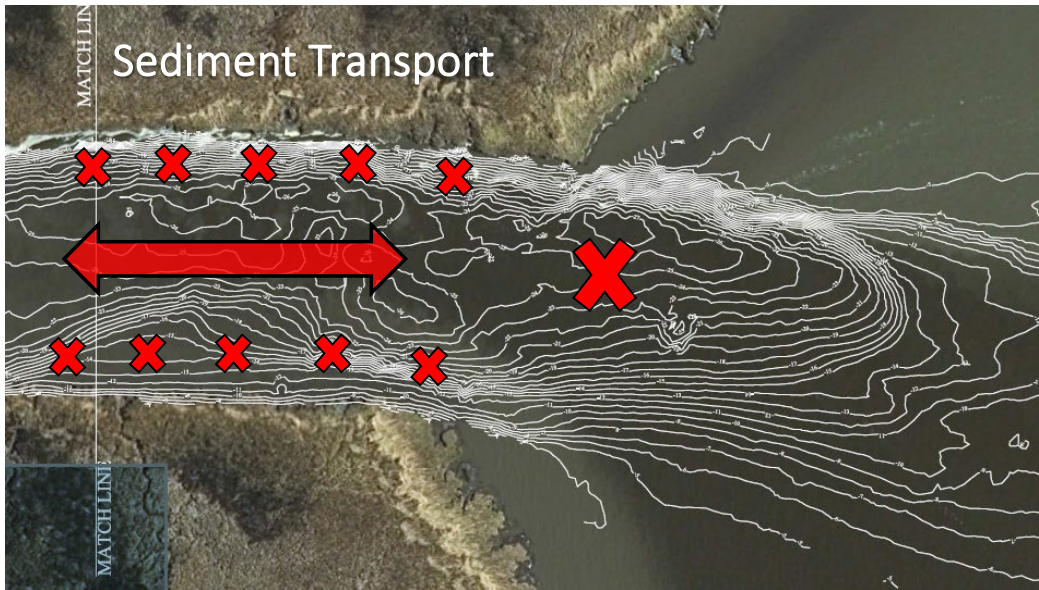
Figure 6. Sediment transport. The velocity of water accelerates within Corey's Ditch. This accelerated water area extends into the Currituck Sound and Barleys Bay moving available sediment back and forth through the ditch. Available sediment here includes suspended sediments already in the Sound in addition to new sediments scoured from the bottom and sides of the ditch.

Sediment enters our Sounds and Bays from a variety of sources. The most common sources are run-off from construction and agriculture, erosion, and the loss of our marshes. Once sediments enter the waters around Knotts Island they are likely to stay due to a “bath tub effect” where north winds move them south and south winds move them north. This constant back and forth not only keeps sediments suspended, but also prevents them from leaving.

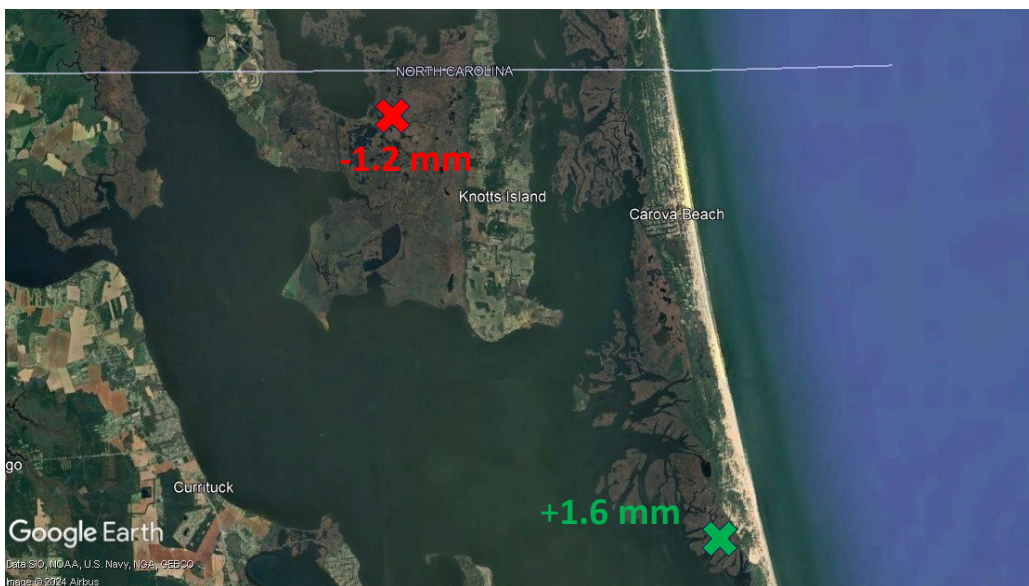
Figure 7. Local Coastal Wetland Elevation Monitoring stations at Mackay Island and Currituck NWR's. Currituck NWR is gaining 1.6 mm/year while Mackay Island is showing a 1.2 mm/year deficit.

Recent, research looking at marsh elevation data ([Moorman et al. 2024](#)) at 20 coastal sites in the south Atlantic geography showed that only 6 of these sites were gaining elevation at rates greater than or equal to the elevations needed to keep up with rising water levels. Local results show that Currituck National Wildlife Refuge is gaining elevation at 1.6 mm/year and Mackay Island NWR has a 1.2 mm/year deficit.

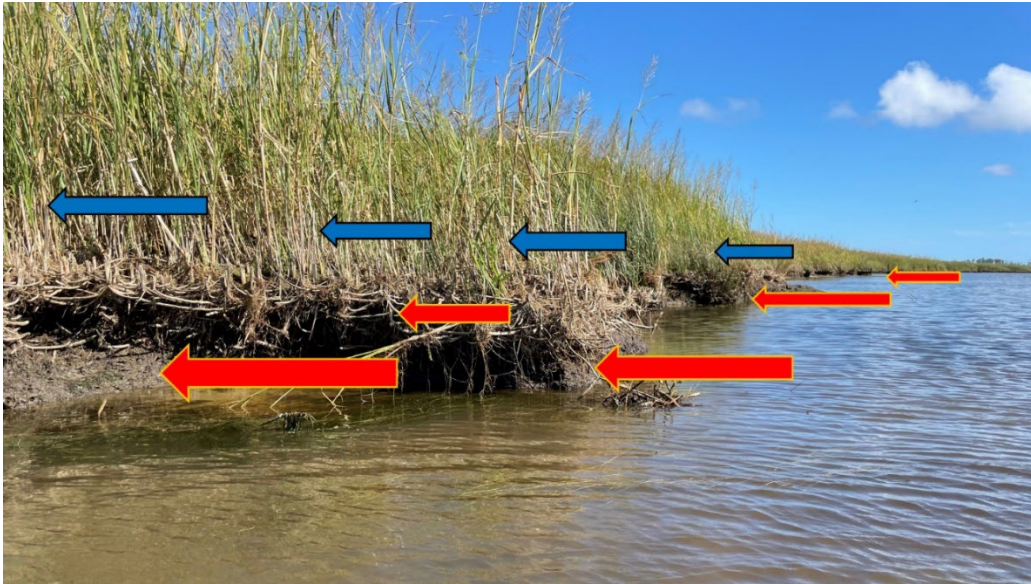
Figure 8. Marshes are very resilient to the effects of flooding and wave energy. Currently there is a delay in water levels going over the marsh at the southern end of Corey's ditch. Water levels below the marsh increases shoreline erosion by increasing the length of time wave energy can undercut the marsh (Red Arrows). When water levels overtop the marsh (Blue Arrows) they can carry sediment into the marsh, building elevation, cleaning the water, and reduce the negative effects of wave energy.

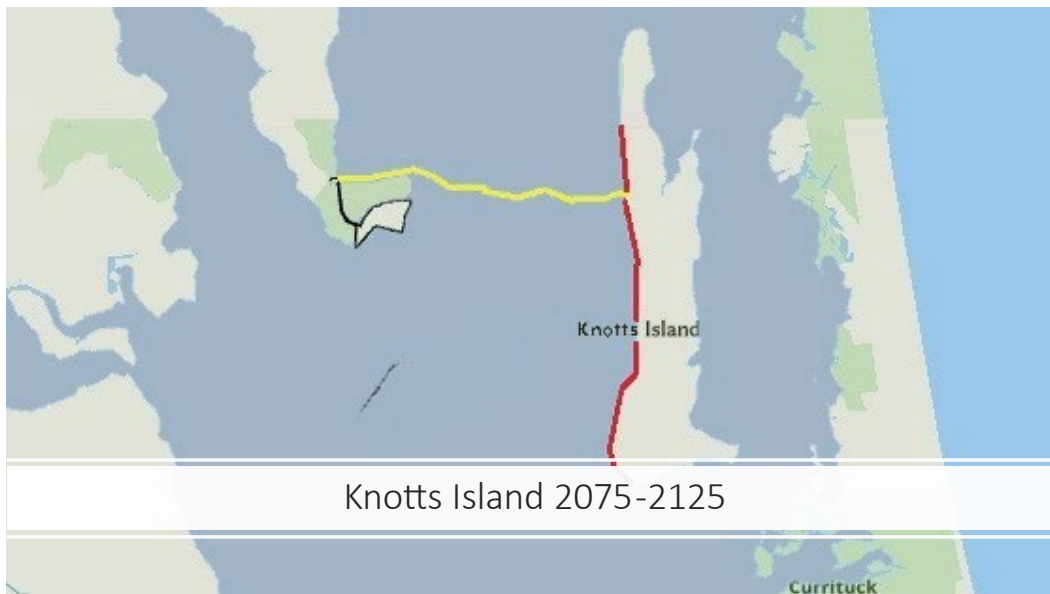
Figure 10. View of Knotts Island if the Mackay NWR marshes are gone. To ensure access to and from Knotts Island, NCDOT will likely need to raise and rock the entire length of the causeway to combat waves over topping the road (yellow line). The entire west facing shoreline of Knotts Island will need shoreline protection to eliminate erosion of the island (Red line).

Loss of the Mackay Island NWR marshes will release ~800,000,000 cubic feet of additional sediment into the waters around Knotts Island, severely limiting sunlight penetration, and increasing the vulnerability of the Marsh Causeway and Knotts Island properties to coastal storms.
