## ACTIONABLE SCIENCE

# Reversing Erosion on Semi-Arid Grassland Ranches: A 10-Year Analysis

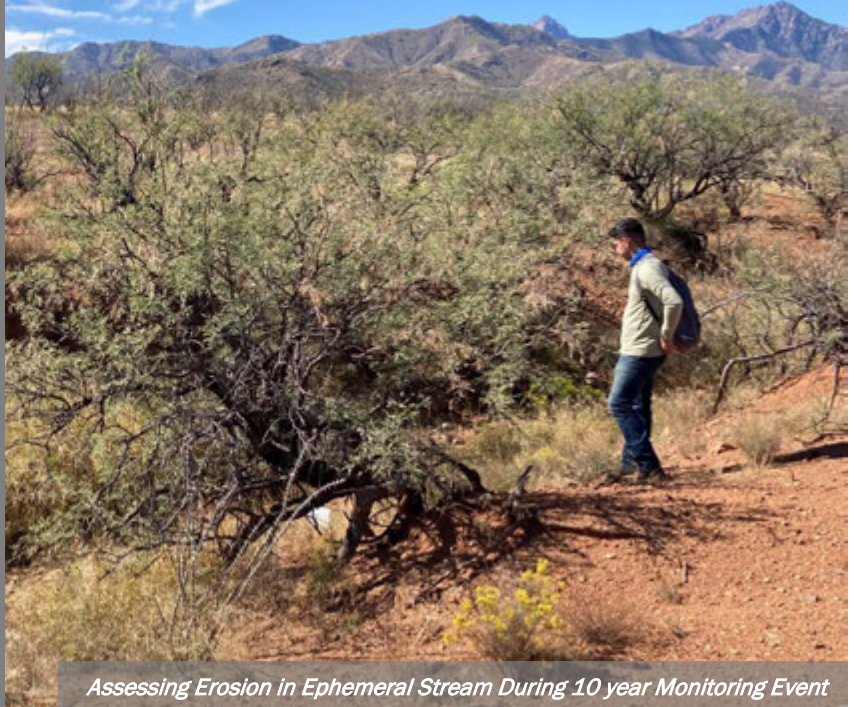
In-channel treatment:  
ORD & baffles
