Imnaha River Weir Cooperative Evaluations 2017-2020

Rod Engle USFWS-LSRCP

Lower Snake River Compensation Plan Office

Assessment of Bull Trout Passage at the Tucannon River Adult Weir/Trap

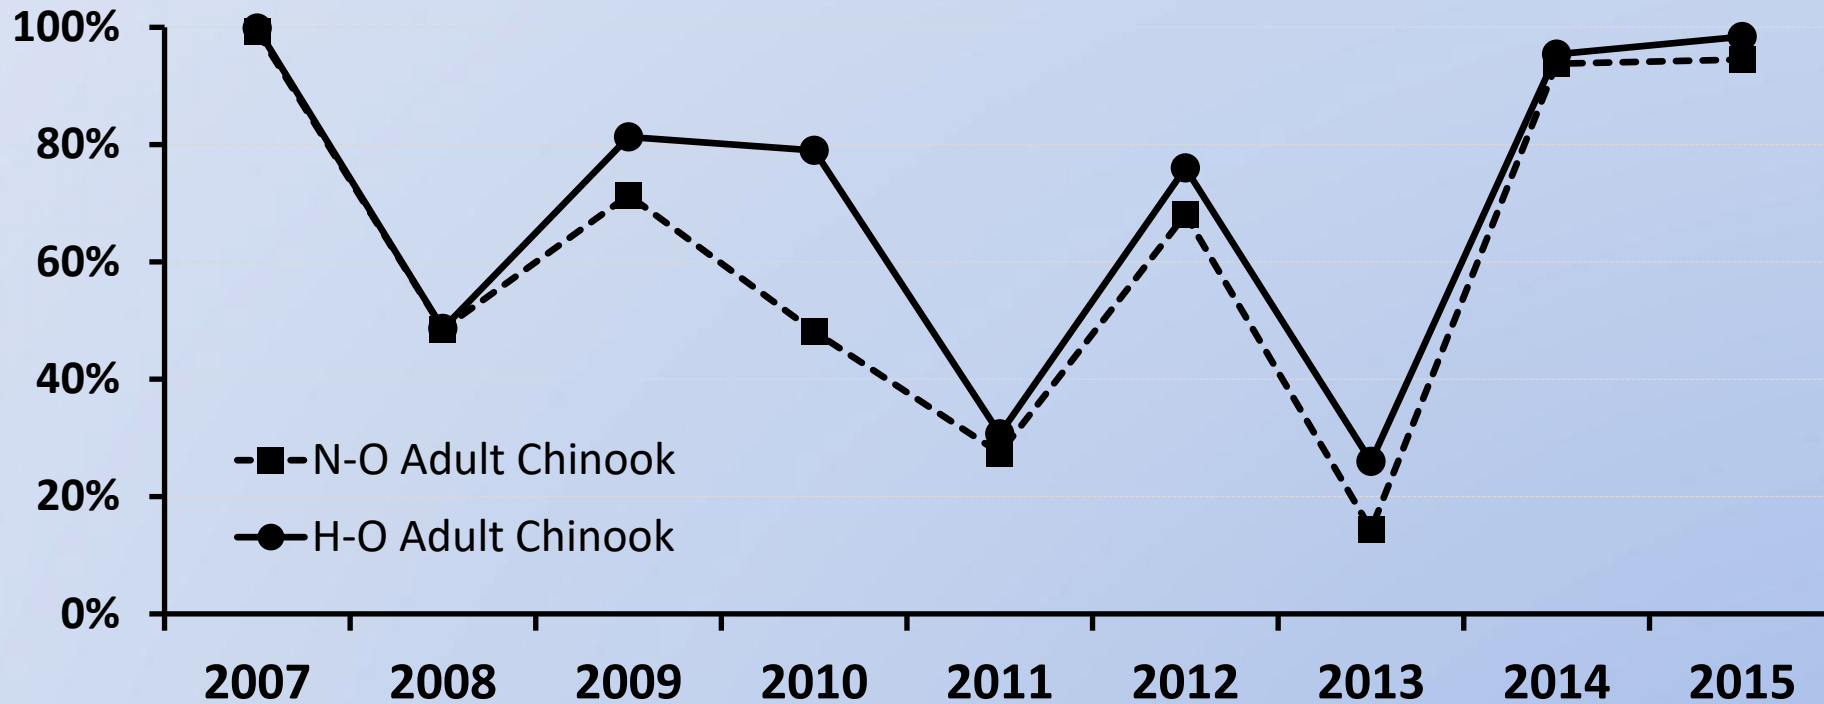
Weir Efficiency (Picket)

Estimates of efficiency, by origin, of the the Imnaha River Picket Weir. Figure/data from Jeff Yanke – ODFW (2016)

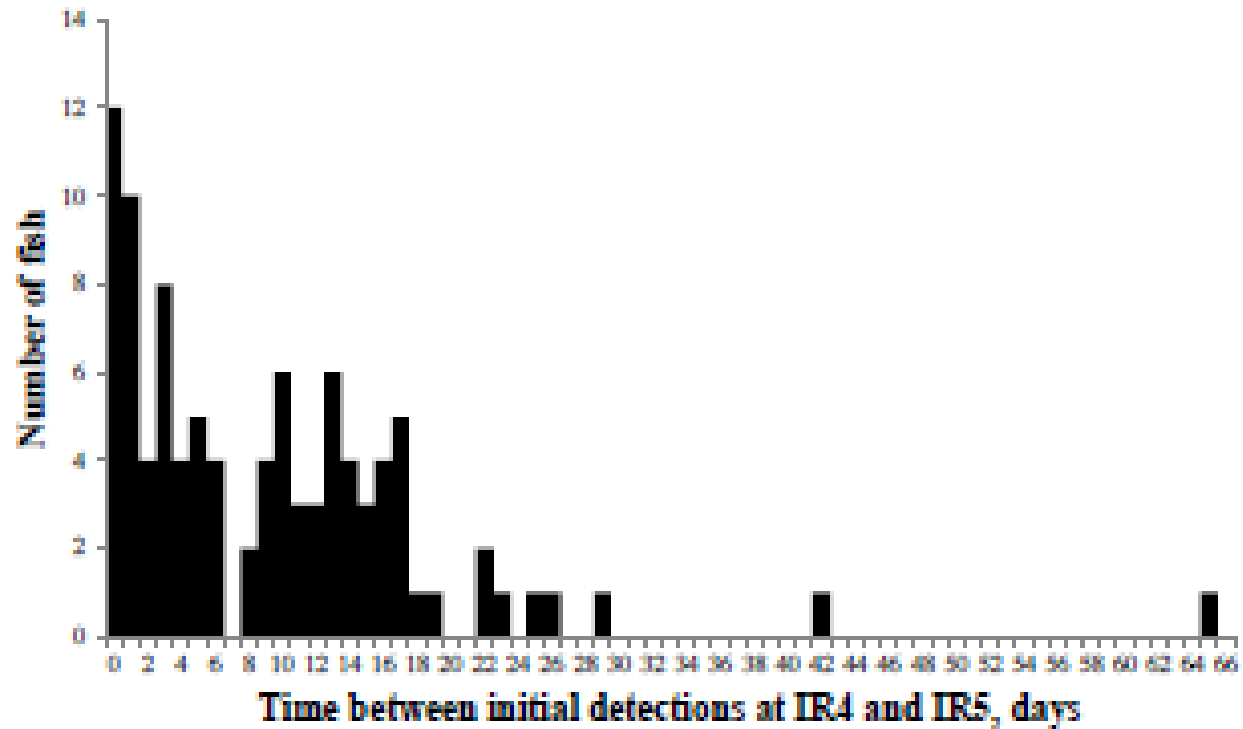
2017 Bull Trout Delay

Figure 4. The number of days it took Bull Trout to move from IR4 to IR5. The number of days represents the time between the initial detection at IR4 and initial detection at IR5.

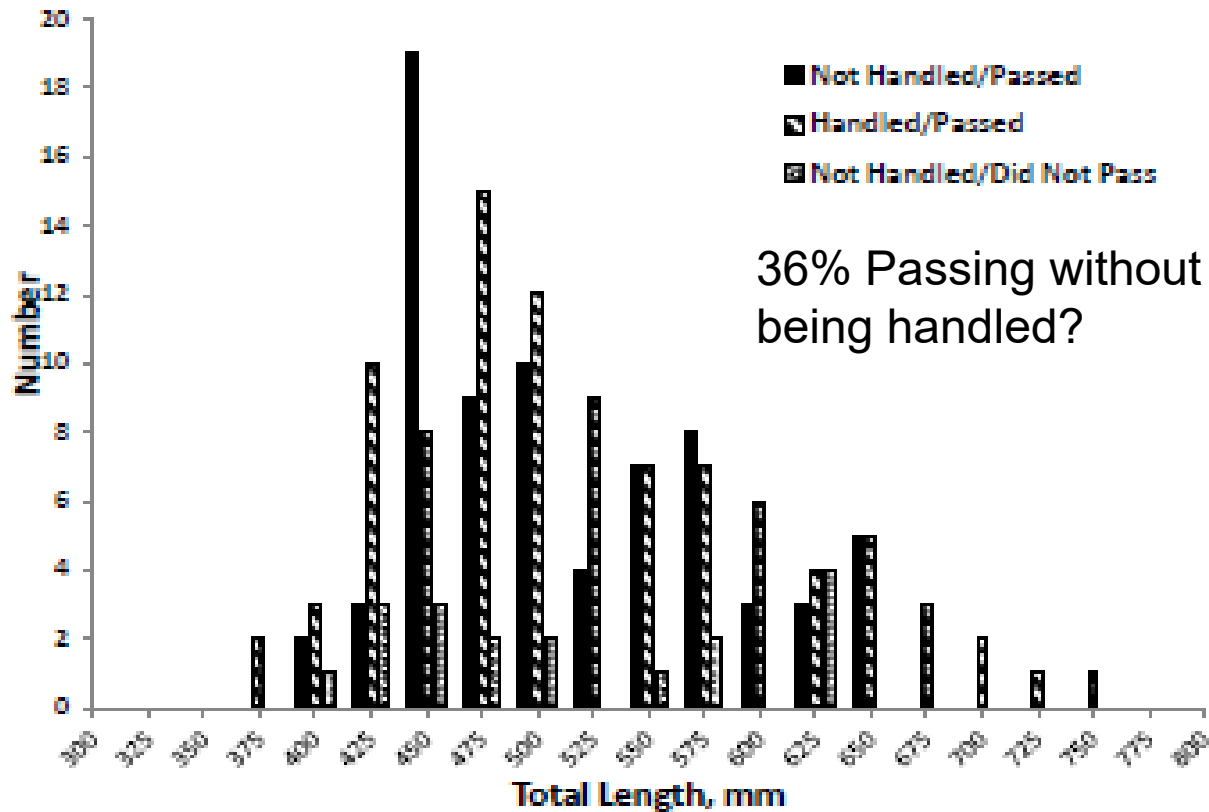
Passing without handling?

Figure 5. The size distribution of Bull Trout exhibiting various migratory behaviors (Passed or Did Not Pass the weir) and passage routes (not trapped and therefore Not Handled or captured in the trap and therefore Handled) at the Innaha River weir (courtesy of R. Wilkinson, Idaho Power Company, personal communication).

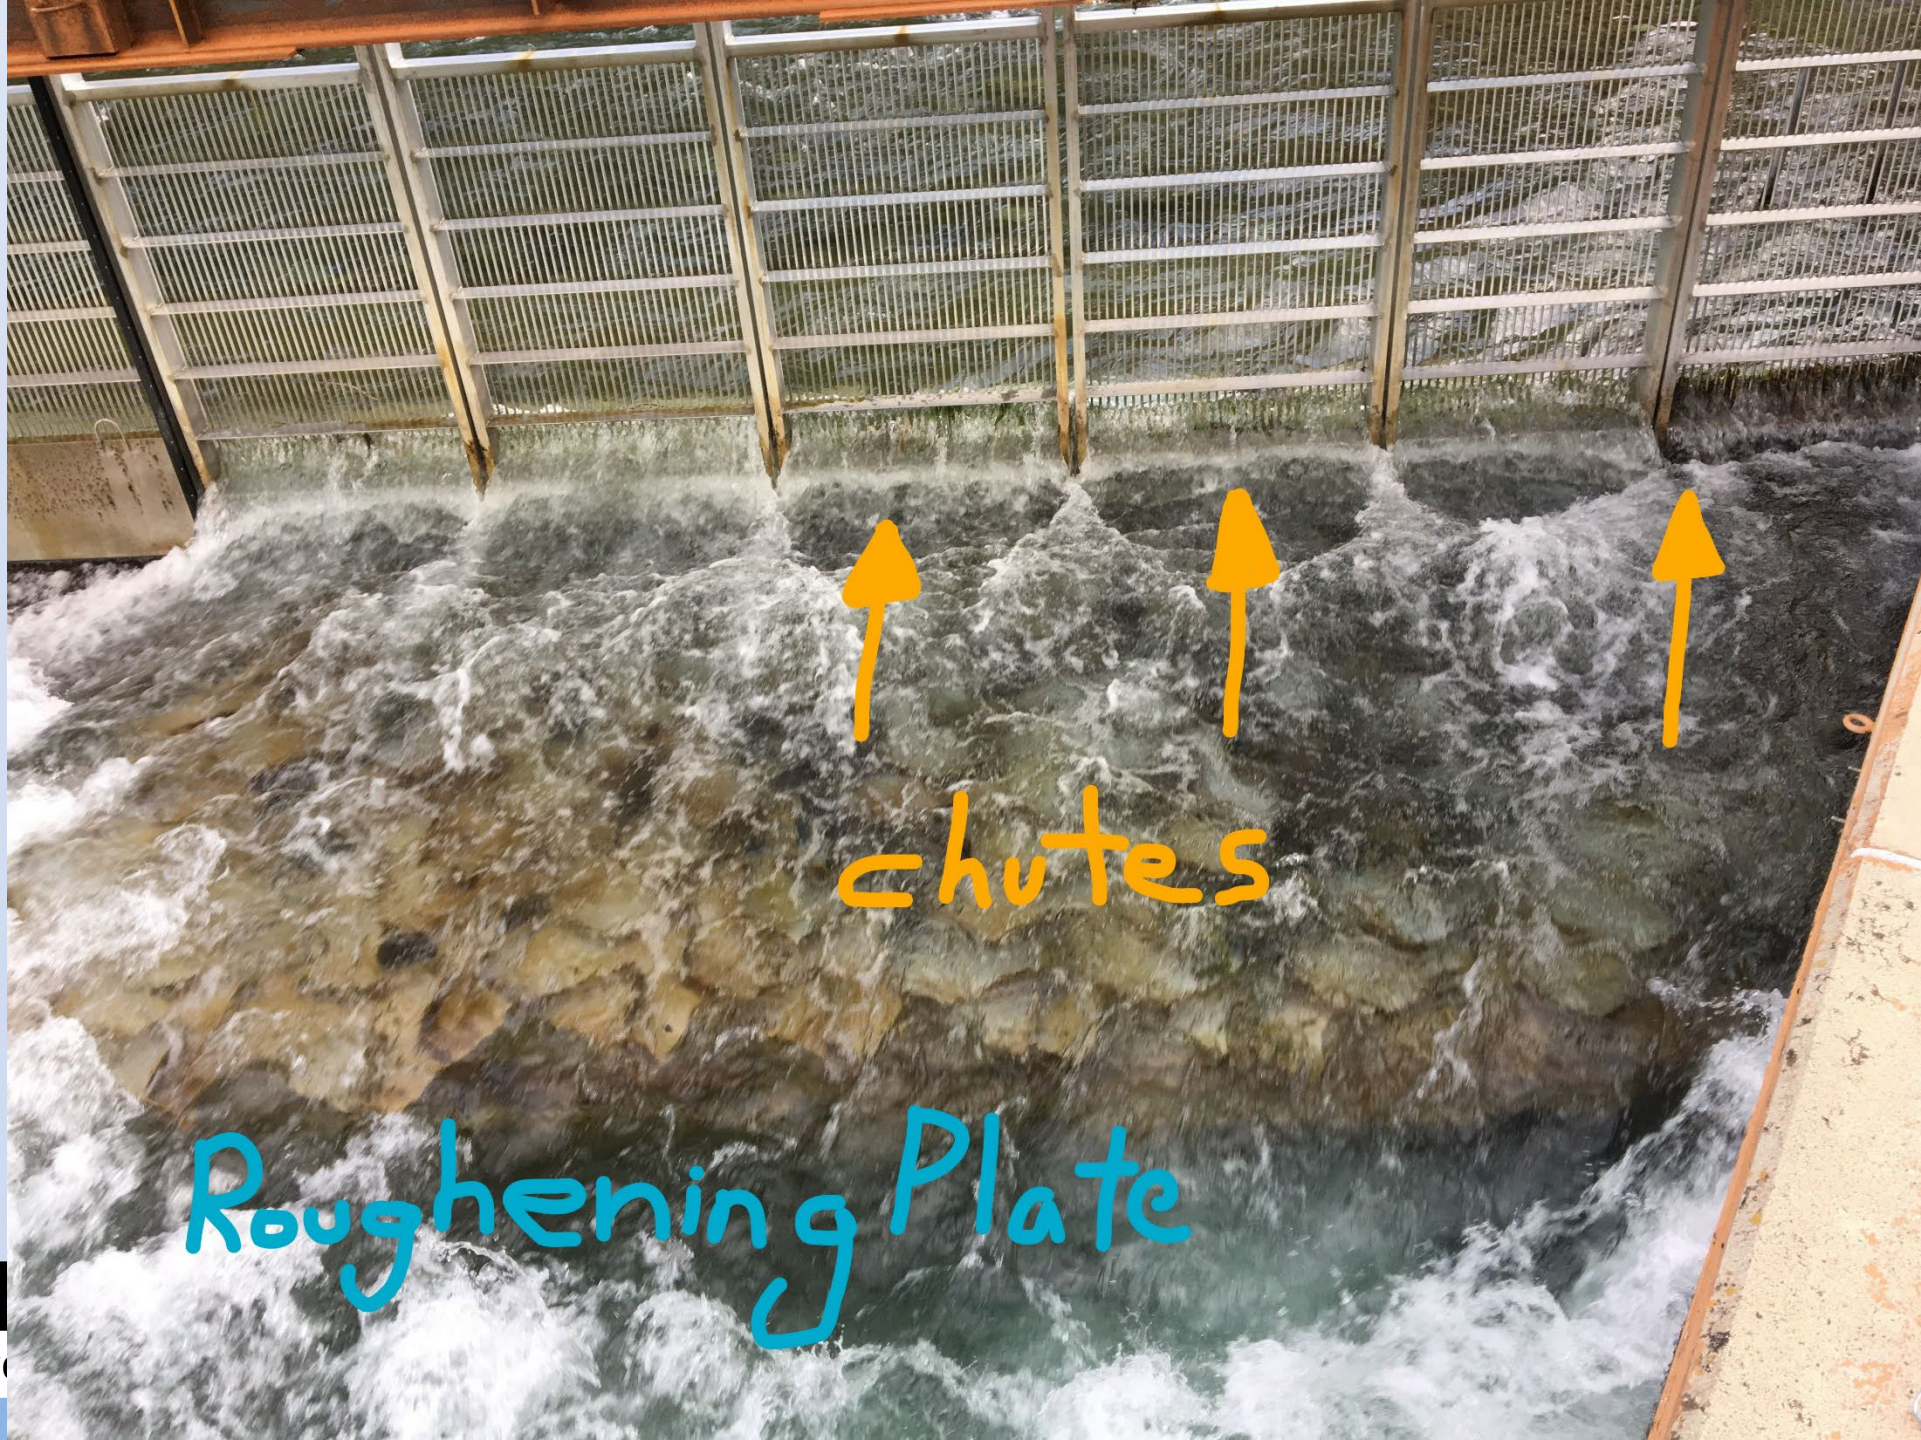
chutes

Roughening Plate

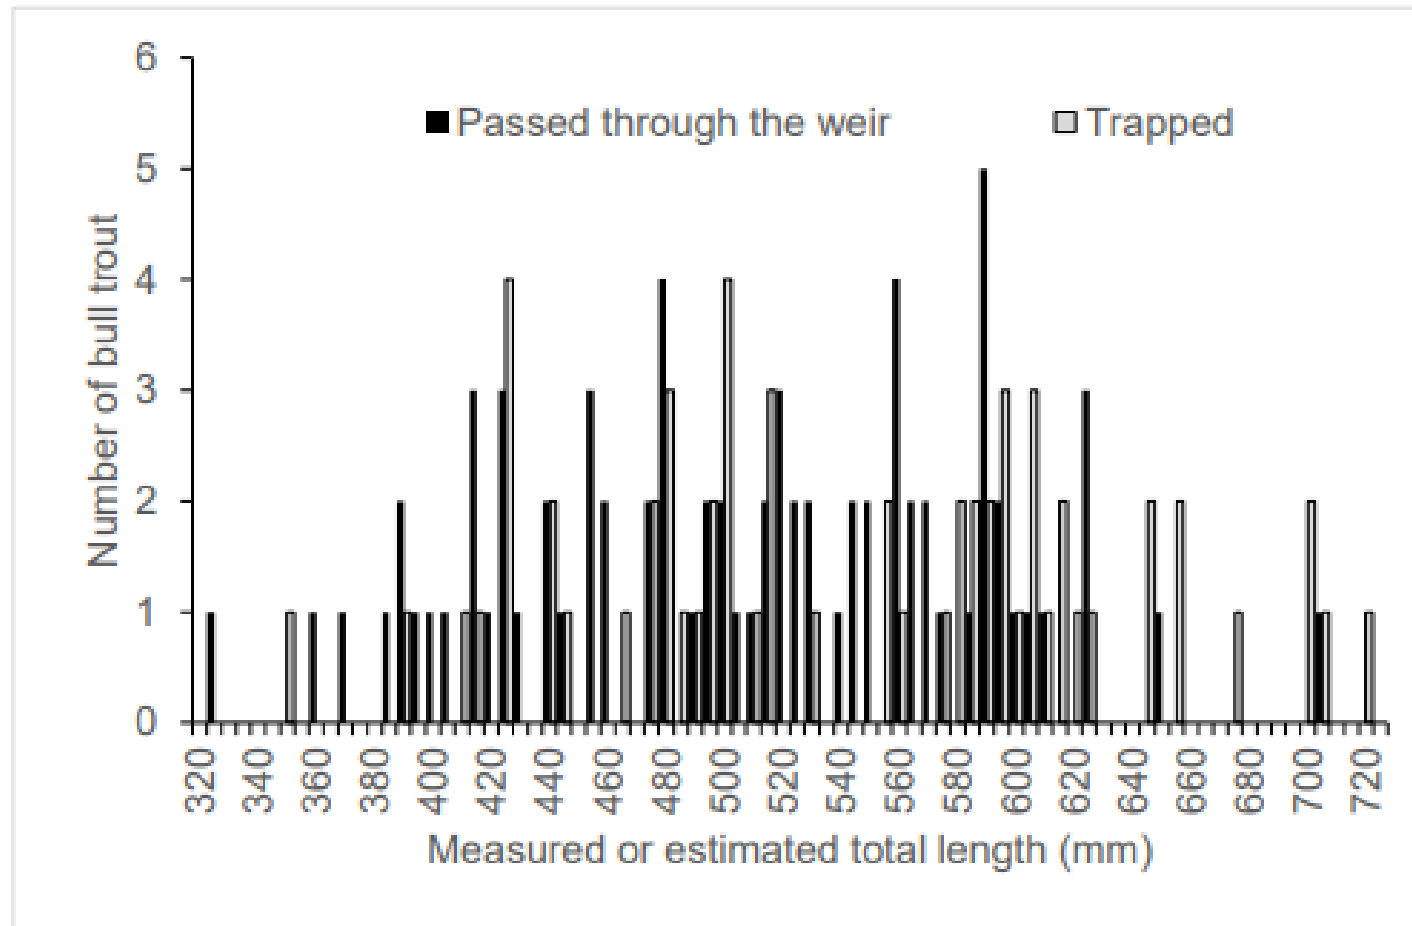
Figure 5. Length frequency distribution of Bull Trout that were trapped and released above or passed through the Imnaha River weir in 2020.

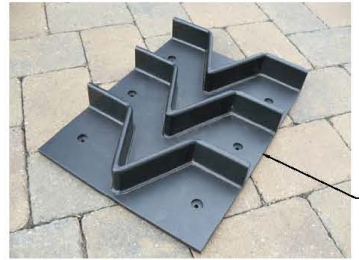
△	10/30/15	RECORD DRAWINGS	DN
△	03/13/15	ISSUED FOR CONSTRUCTION	PG
REV.	DATE	DESCRIPTION	BY
IMNAHA FISH FACILITY			
EXCLUSION FISH BARRIER			S140
SILL PLAN AND SECTION			
DESIGNED	DRAWN	CHECKED	DATE
MB	RG	PG	03/13/15
DRAWING NO.			1F-DR-XXX-XXX-32.0

- SHEET NOTES:**
1. PROVIDE 3 GAPS IN SILL PLATE FOR LOW FLOW RESIDENT SPECIES PASSAGE AS ILLUSTRATED NEAR LEFT BANK.
 2. OPTIONAL - INSTALL ROUGHNESS ELEMENTS TO IMPROVE RESIDENT SPECIES PASSAGE AT LOW FLOWS DURING NON-COLLECTION PERIODS.
 3. ROUGHNESS ELEMENT SHOWN PAINTED. STAINLESS STEEL ELEMENT REQUIRED.

2 ROUGHNESS ELEMENT DETAIL
Scale in mm: 0 250 500
Scale in Feet: 0 1 2

3 ROUGHNESS ELEMENT DETAIL
SOURCE: AQUATIC CONTROL ENGINEERING

A SECTION
Scale in mm: 0 250 500
Scale in Feet: 0 1 2

B ROUGHNESS ELEMENT SECTION
Scale in mm: 0 250 500
Scale in Feet: 0 1 2

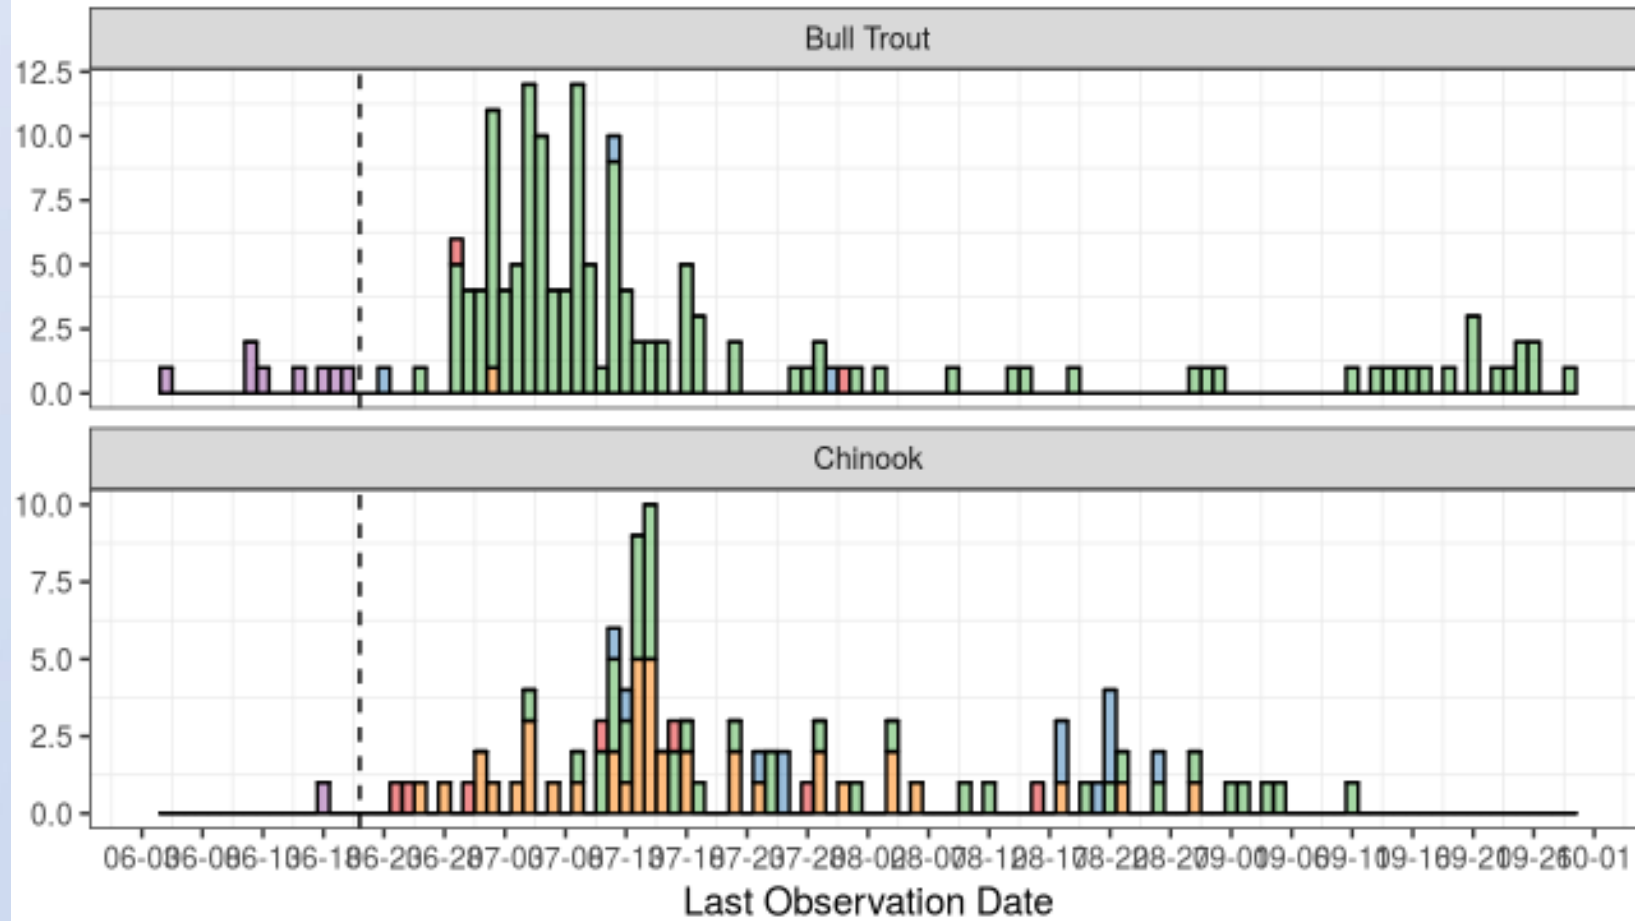
Tag status: last detection at IR4/IR5/IML/IMNAHW on or after weir installation

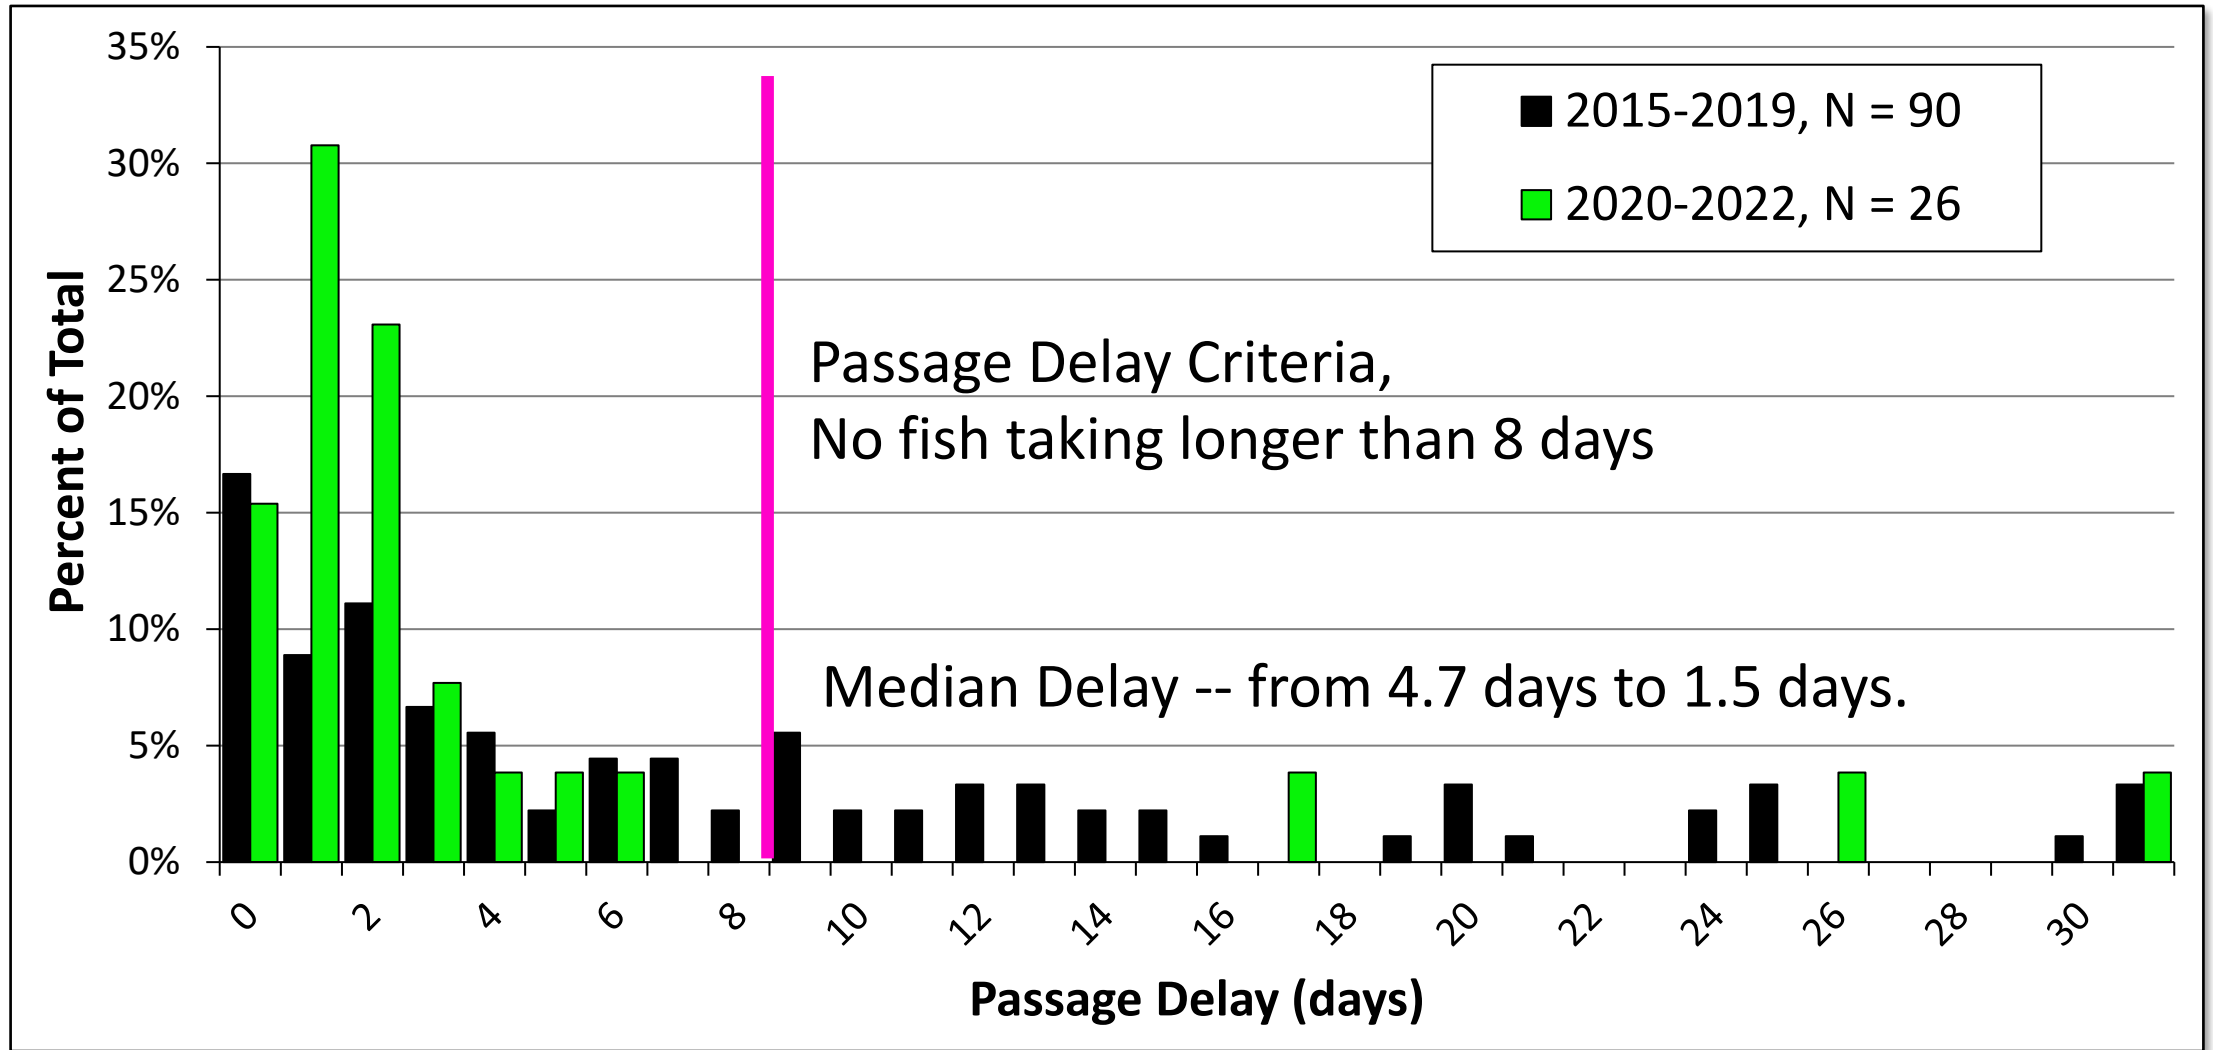
Passage Delay

Time it takes fish to move upstream past the dam.

- Some Bull Trout still taking longer than 8 Days, but passage delay of fish (all species – SH, SPCH) has decreased since the trap fyke was changed.

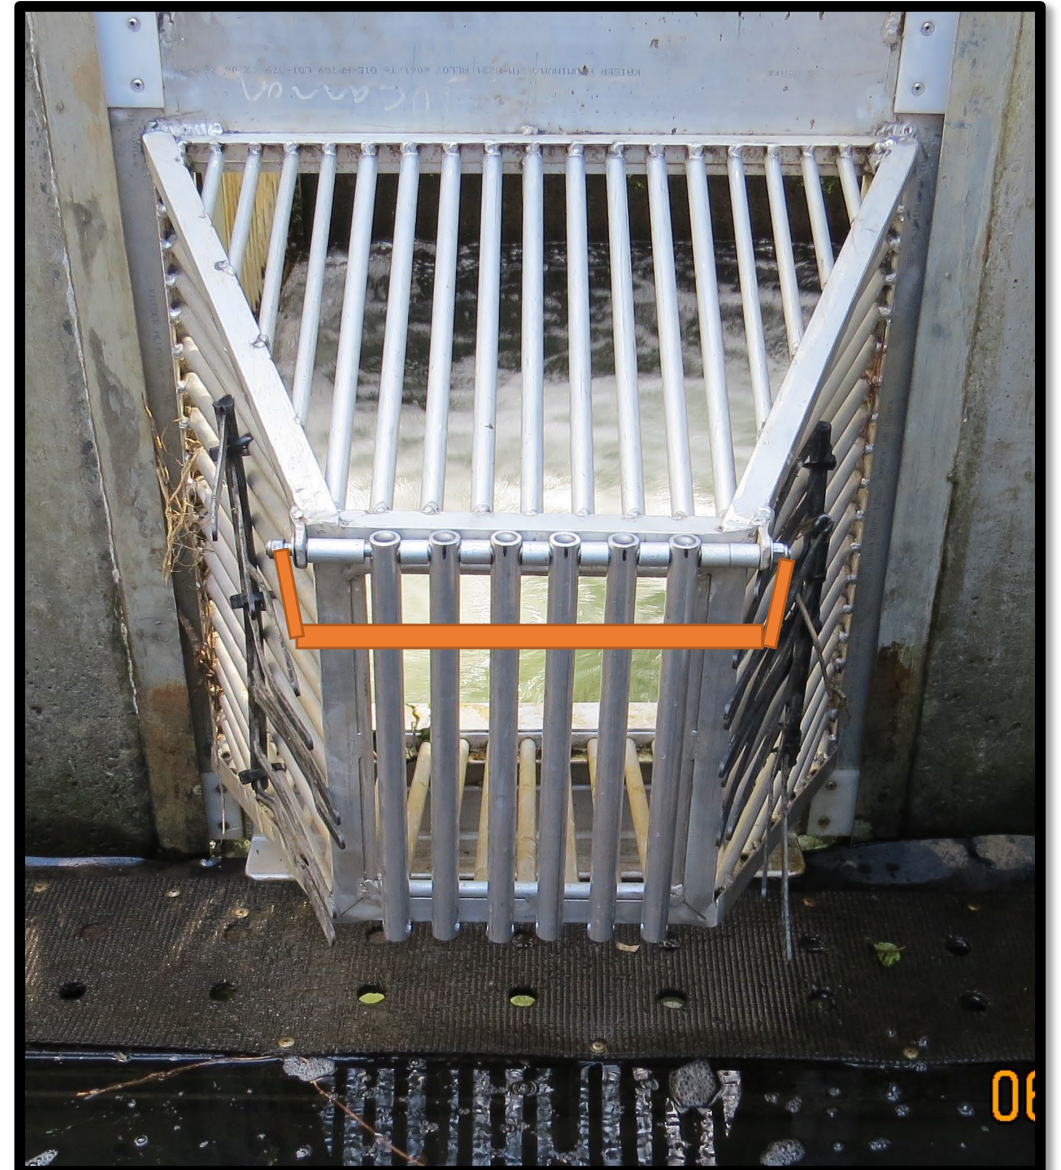
New Trap Fyke

- **The new trap fyke has nearly eliminated escapement**

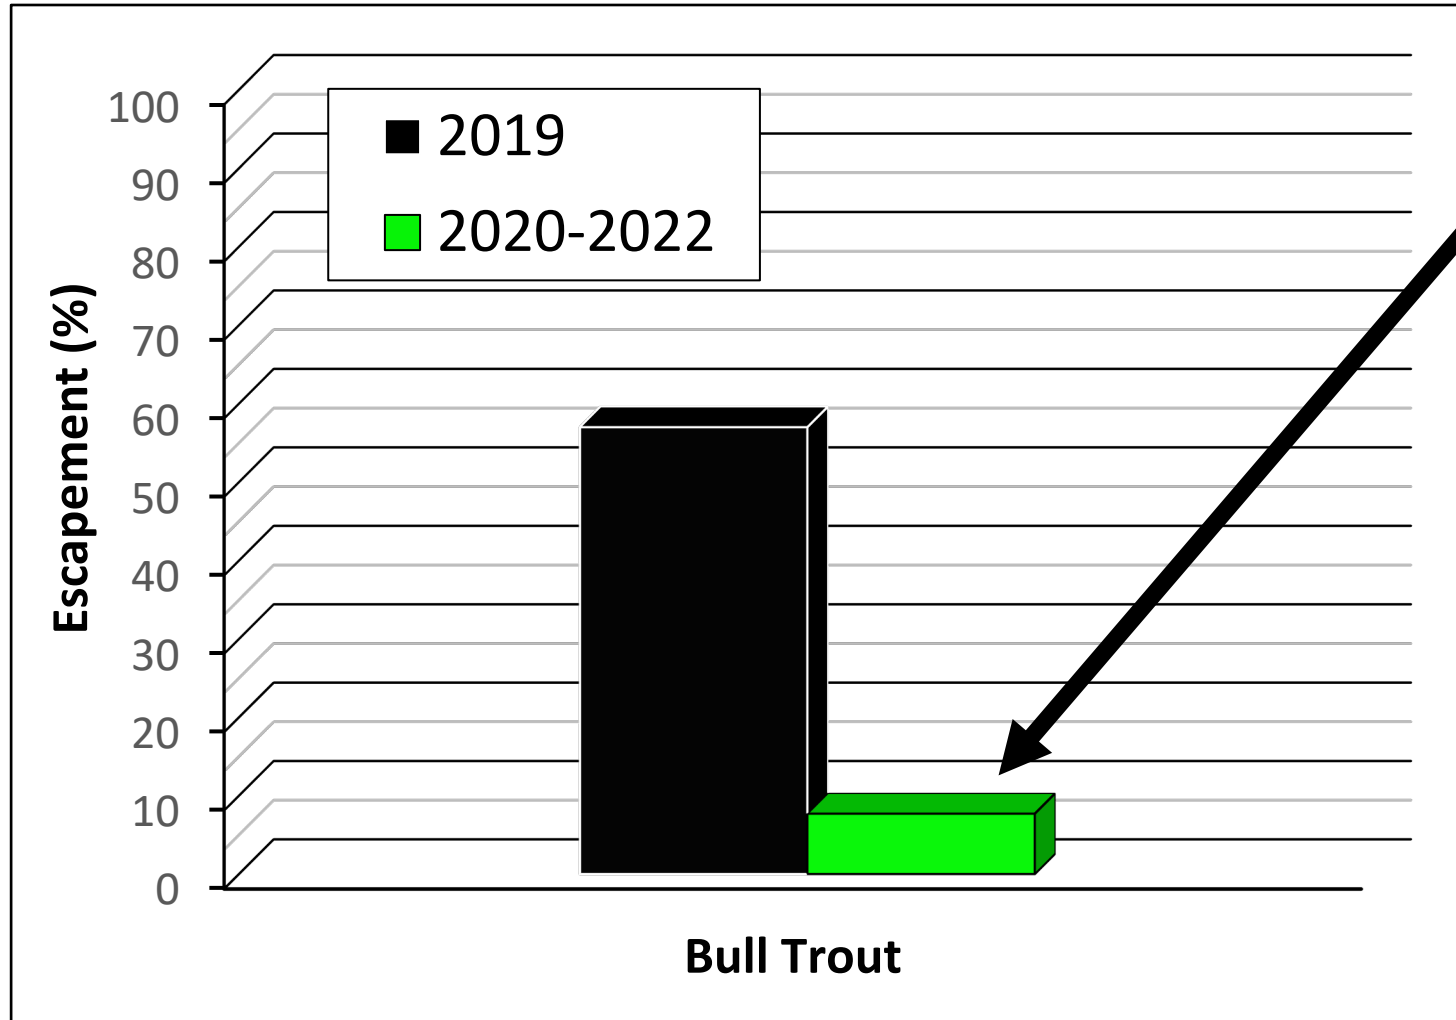
Trap Escapement Rates

2 of 26 fish

Entered trap at nearly the same time late in the afternoon 5/16/22.

Exited the trap within an hour of each other early in the morning on 5/17/22

Bar(s) got stuck in up position for a short time??
