# 2021 Post-Construction Bat Mortality Monitoring Report Wildcat Wind Farm

# Madison and Tipton Counties, Indiana

Project #193707045

February 14, 2022

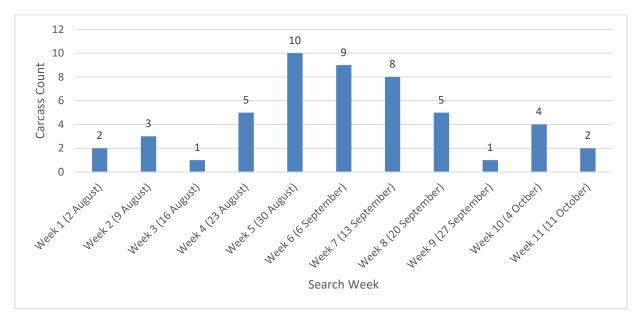
Figure 2. Bat carcasses found by week during the 2021 post-construction standardized surveys (2 Aug through 15 October) at the Wildcat Wind Farm, Tipton and Madison counties, Indiana.

During the post-construction monitoring period, bats were found during every week of searches (Figure 2). The greatest number of bats found during a single week occurred the week of 30 August (week 5; n=10; 20.0%), followed by week 6 (6 September; n=9; 18.0%). The fewest number of bats found during a single week occurred during weeks 3 and 9 (16 August and 27 September, respectively) when one bat was found (n=1; 2.0%) (Figure 2).
