APPENDIX D: Bridge/Culvert and Structure Bat Assessment Form Guidance

Federal Transportation Agency/State Department of Transportation (DOT) Preliminary Guidelines for Using the Bridge/Culvert and Structure Bat Assessment Form

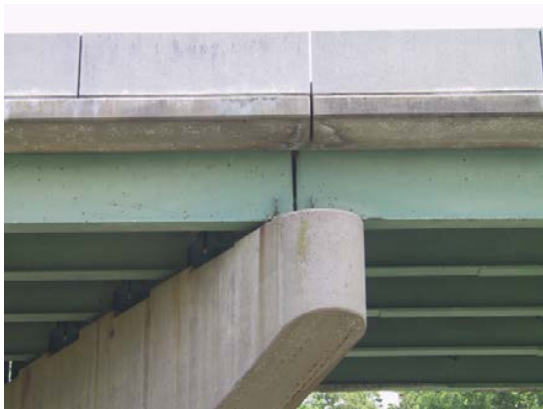
Photo 3: Example of open concrete joint used by bats

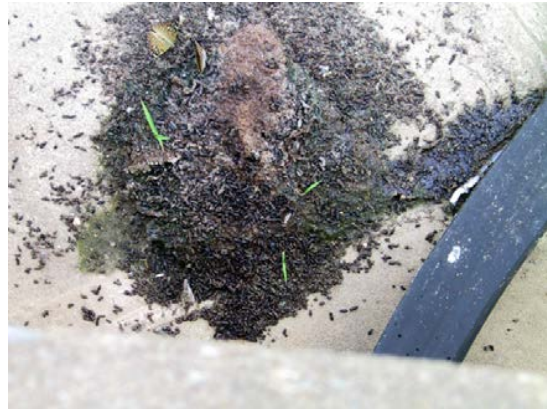
Photo 4: Guano deposits visible from bridge deck on top of pier

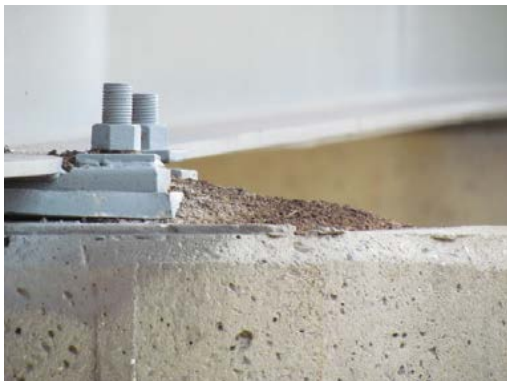
Photo 5: Guano deposit on pier, obscuring structural features.

Expansion joints can provide protected cover for bats (Photos 2 and 5), but do not always provide habitat, depending upon whether they are obstructed by road debris or other blockages. If possible during the assessment, individuals should use a flashlight to look into expansion joints or cracks. Guano may be present under joints if being used by bats (Photos 7 and 8).

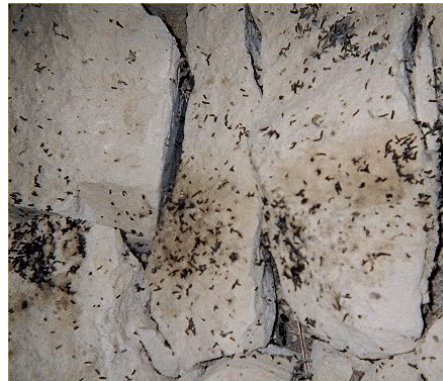
Photo 6: Bat Guano on riprap

Bat droppings are small (mouse-like in appearance but less regular) brown or black pellets (Photos 6 - 8). Older droppings may be gray in color. These droppings will accumulate on the ground; floor of a covered bridge/culvert or structure; or on structural components below where bats roost. Droppings may also adhere to support beams and walls below roosts.

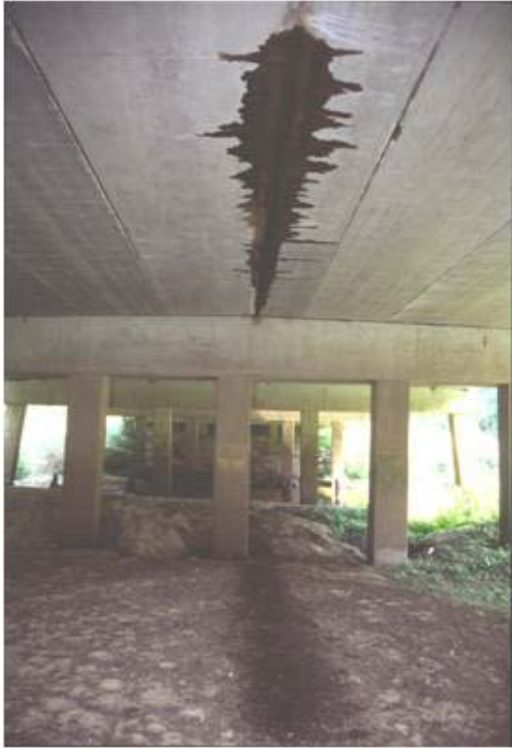
Photo 7: Staining along longitudinal joint.
Guano deposits on the ground.

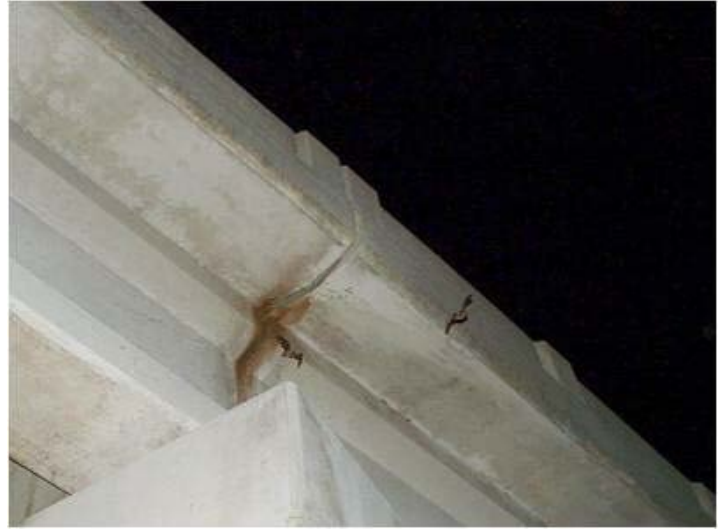
Photo 8: Staining on underside of expansion joint from bat use.

Day: Look for bats flying or roosting (hanging) during the assessment (Photo 1, 2, & 8). A flashlight or headlamp will be needed and binoculars may be necessary when viewing higher areas. If bats are present; record numbers as best as possible and their locations. Note any dead or injured bats. A sketch map would helpful (use bridge plan sheet as base for sketch).

Stains may appear wet and are usually found in dark places. Look for four to six inch wide dark stains located on concrete support beams and walls immediately below the ceiling of the bridge or culvert, and beneath joints (Photos 8 - 11).

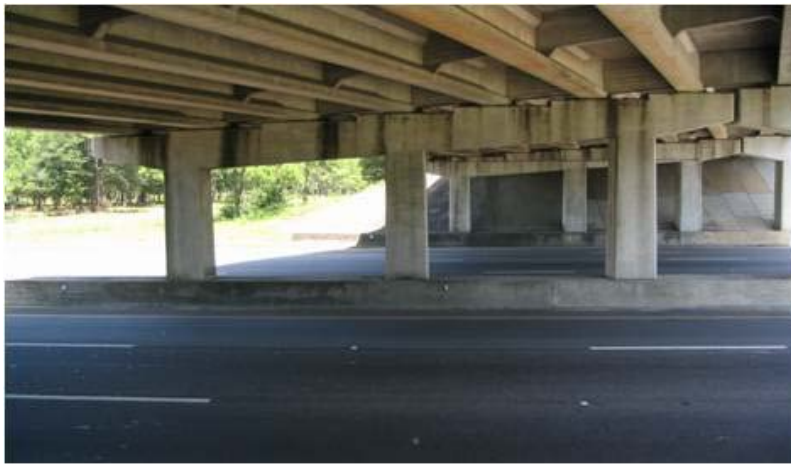
Photo 9: Staining on sides of pier caps

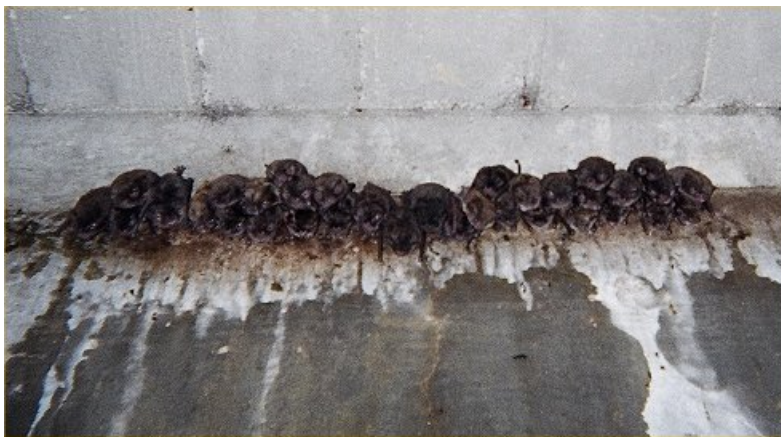
Photo 11: Bats roosting & associated staining

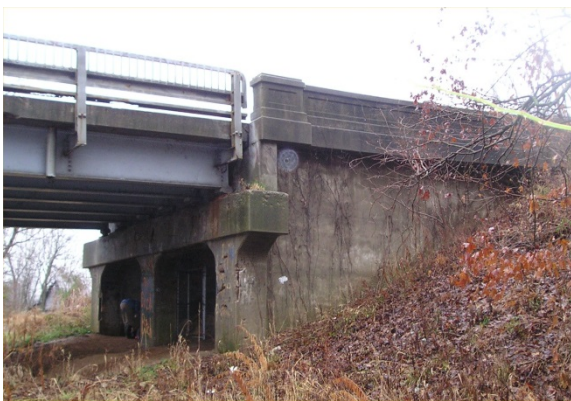
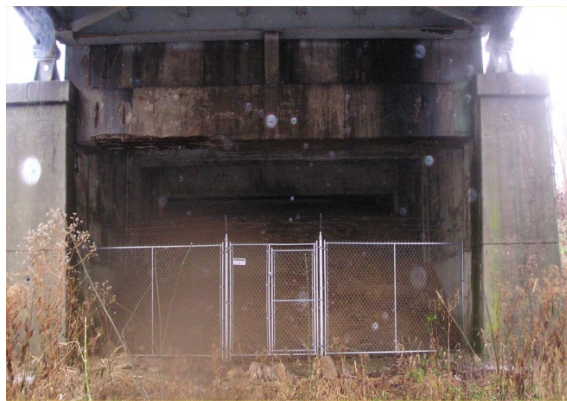
Photo 12 and 13: Bridge design mimicking “cave-like” atmosphere

While assessing bridges/culverts or structures, look for dark environments that mimic cave-like conditions such as under the deck in the case of a bridge (Photos 12 and 13) or an attic in the case of a

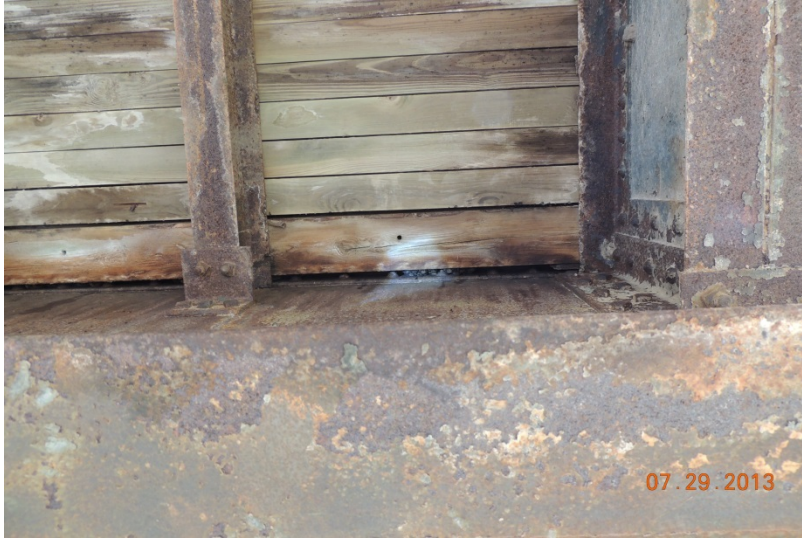
Photo 14: NLEBs roosting under a timber decked bridge
