Preassessment Data Report #2
M/V *Selendang Ayu* Oil Spill
Surveys of Intertidal, Subtidal, and Anadromous Stream Habitats

NOAA
Damage Assessment, Remediation, and Restoration Program

January 2008

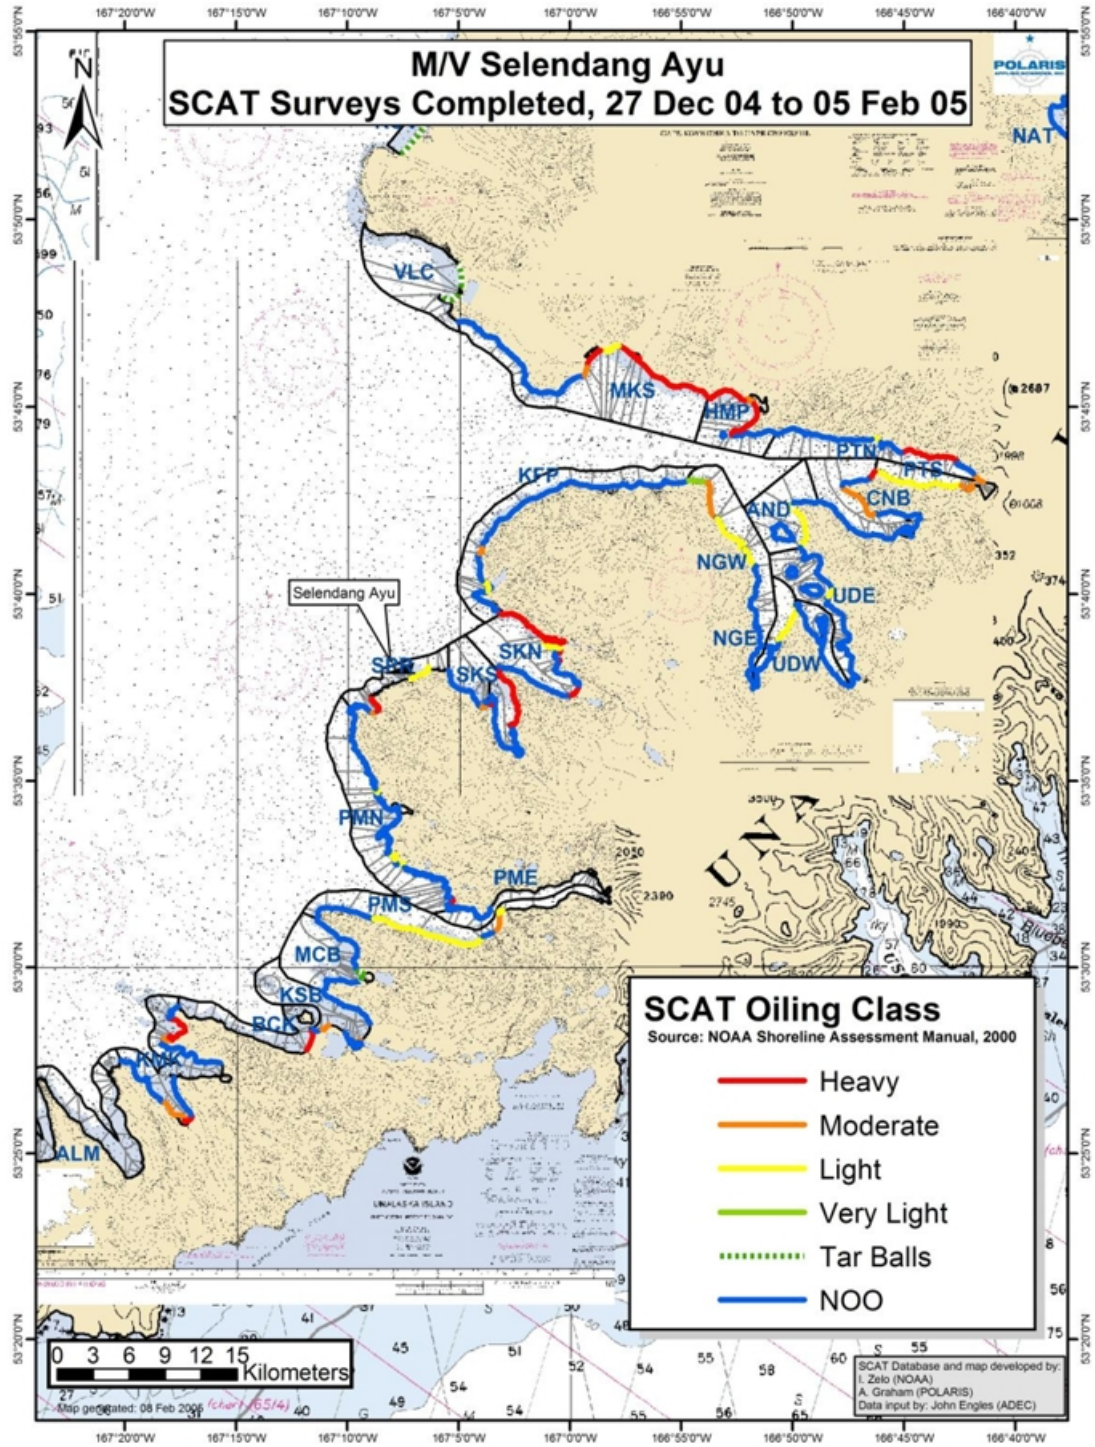
Figure 1. SCAT survey map showing most of the area surveyed in the studies described in this report. Chernofski Harbor is about 20 km southwest of “ALM” (Alimuda Bay) at lower left.

On 8 December 2004, the *Selendang Ayu* grounded and broke in half on Spray Cape, Unalaska Island, 53° 38' 04" N, 167° 07' 30" W (Figure 1). An estimated 335,732 gallons of fuels, mostly Intermediate Fuel Oil (IFO 380), were released following the grounding. Additional information about the incident is available at the Unified Command Website for the *Selendang Ayu* incident:
http://www.dec.state.ak.us/spar/perp/response/sum_fy05/041207201/041207201_index.htm.

Shoreline location segments (e.g., “SKN14”) were identified using the alphanumeric system instituted by the *Selendang Ayu* Unified Command (see map in Figure 1).

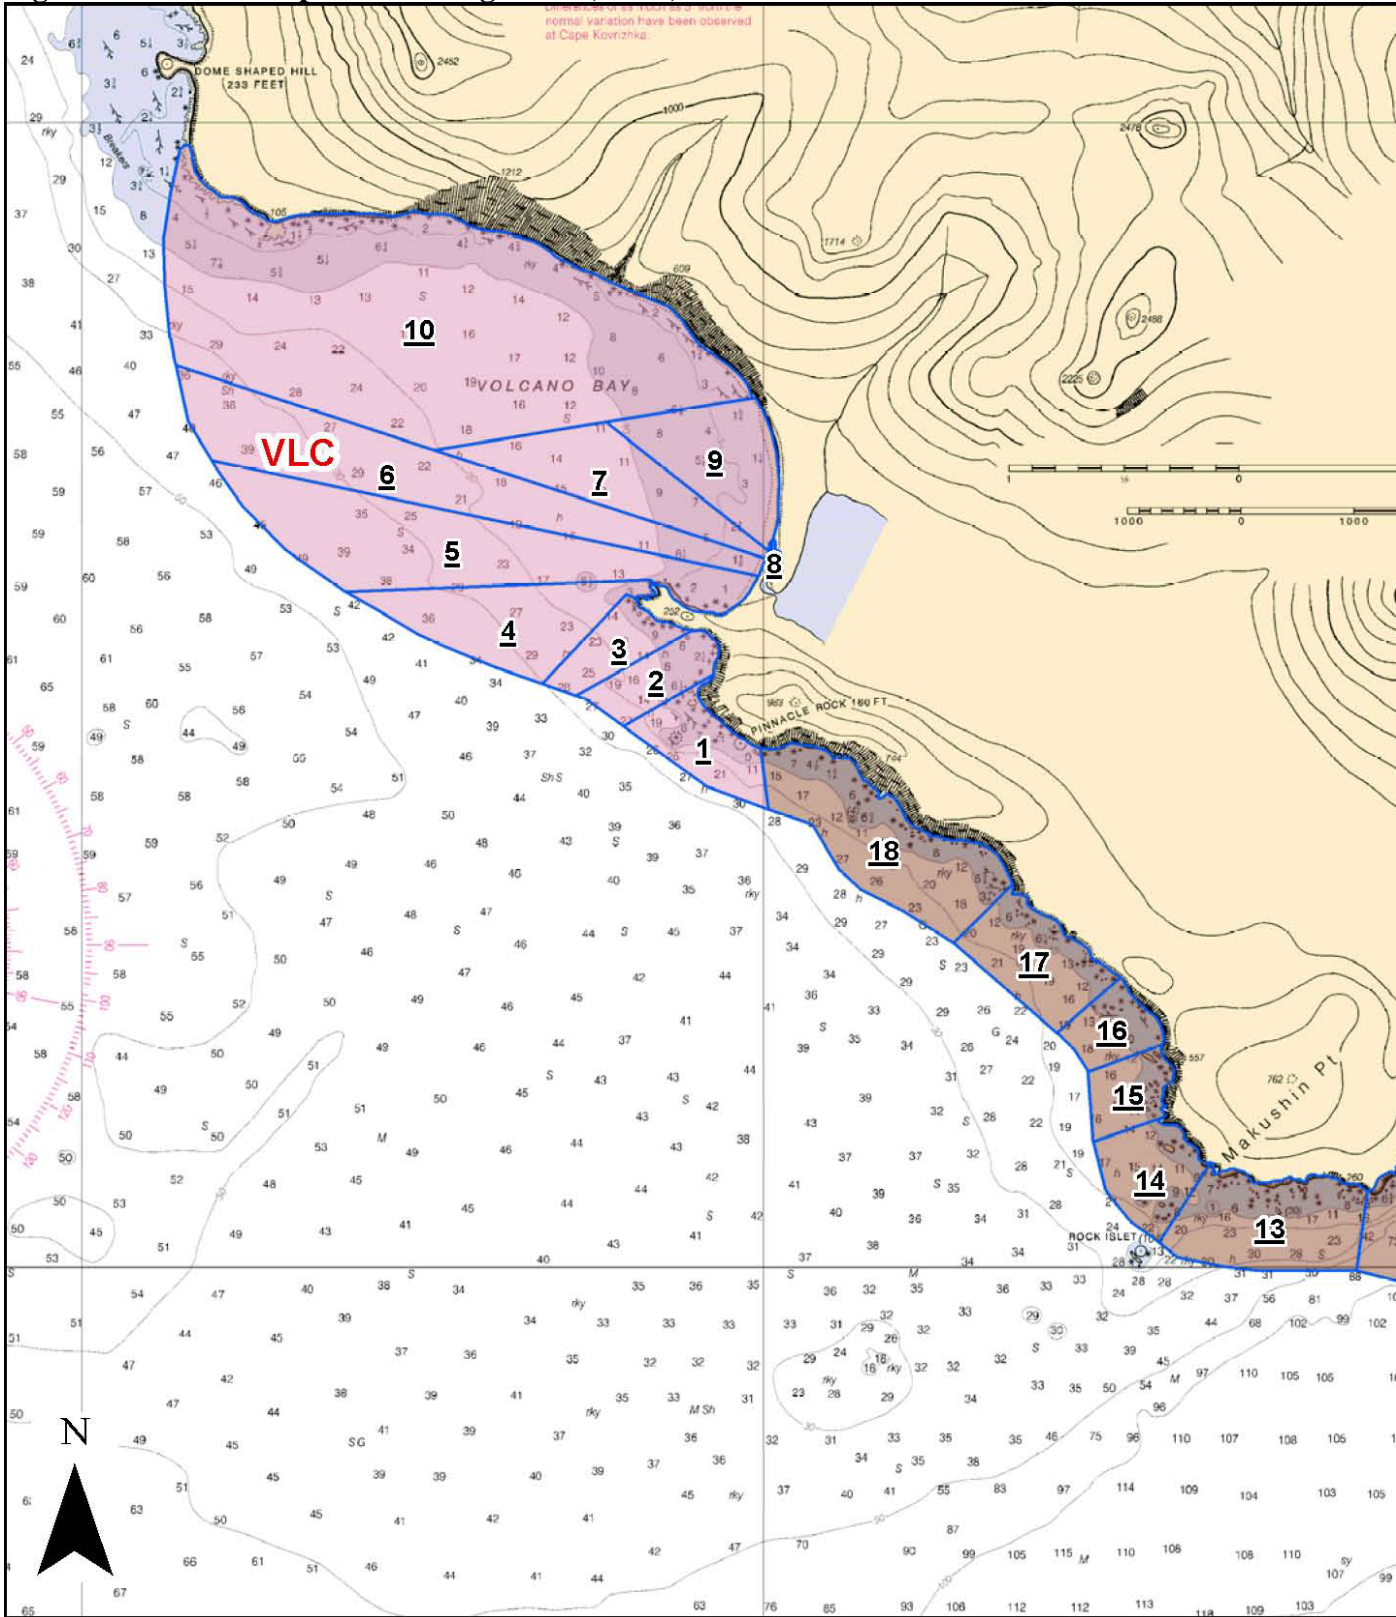
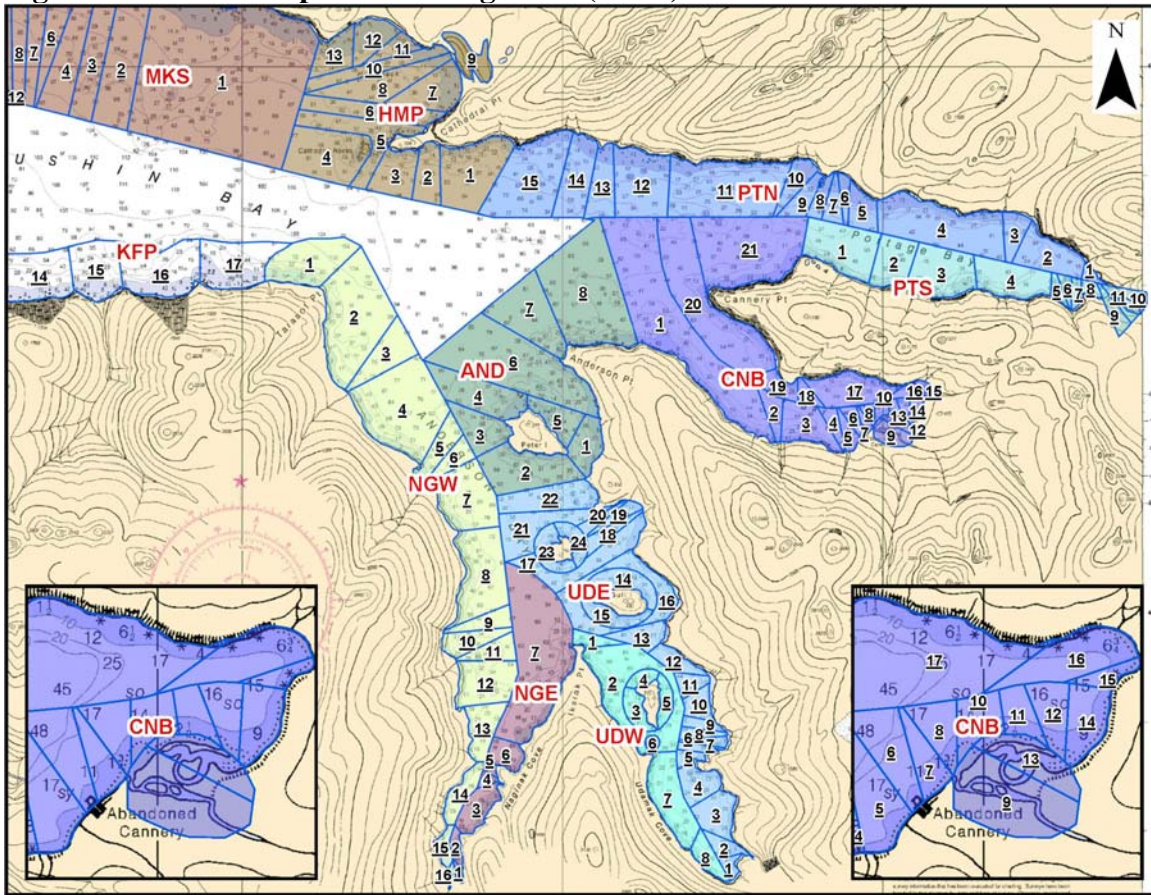
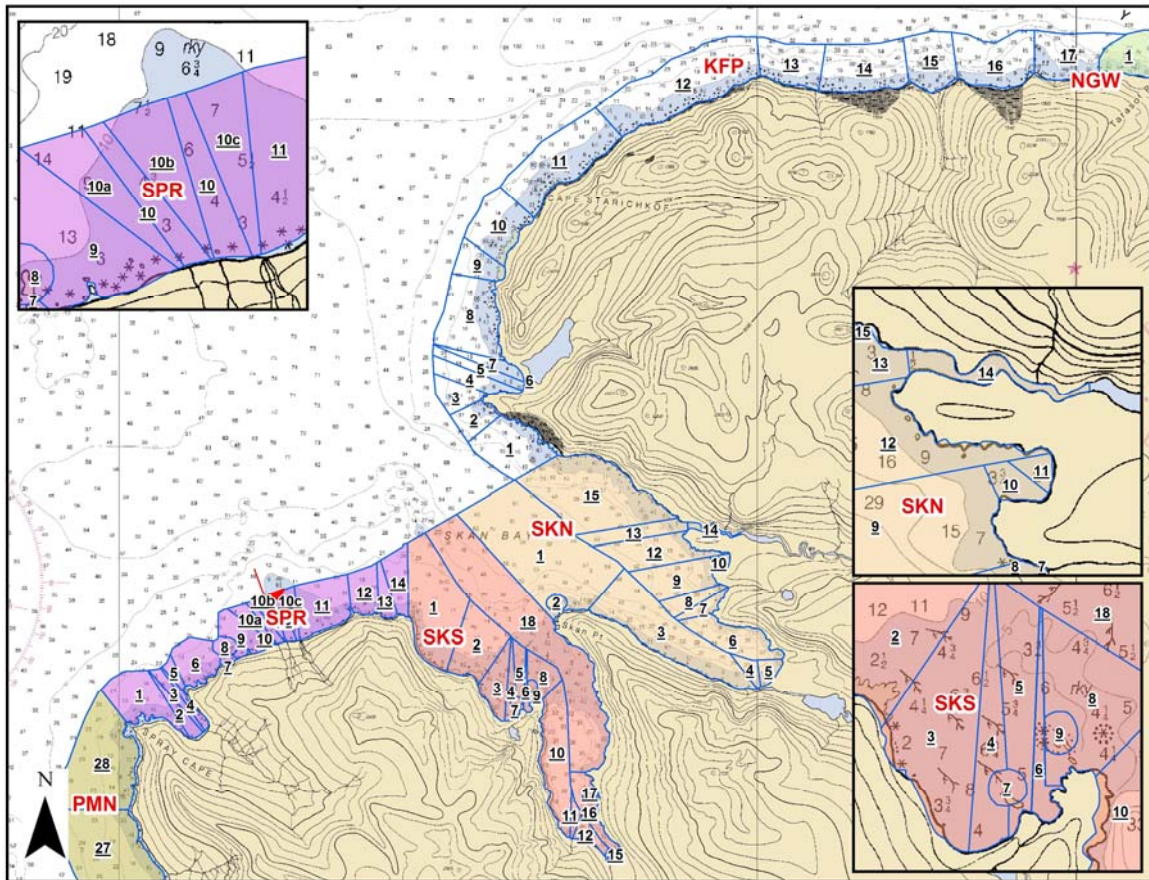
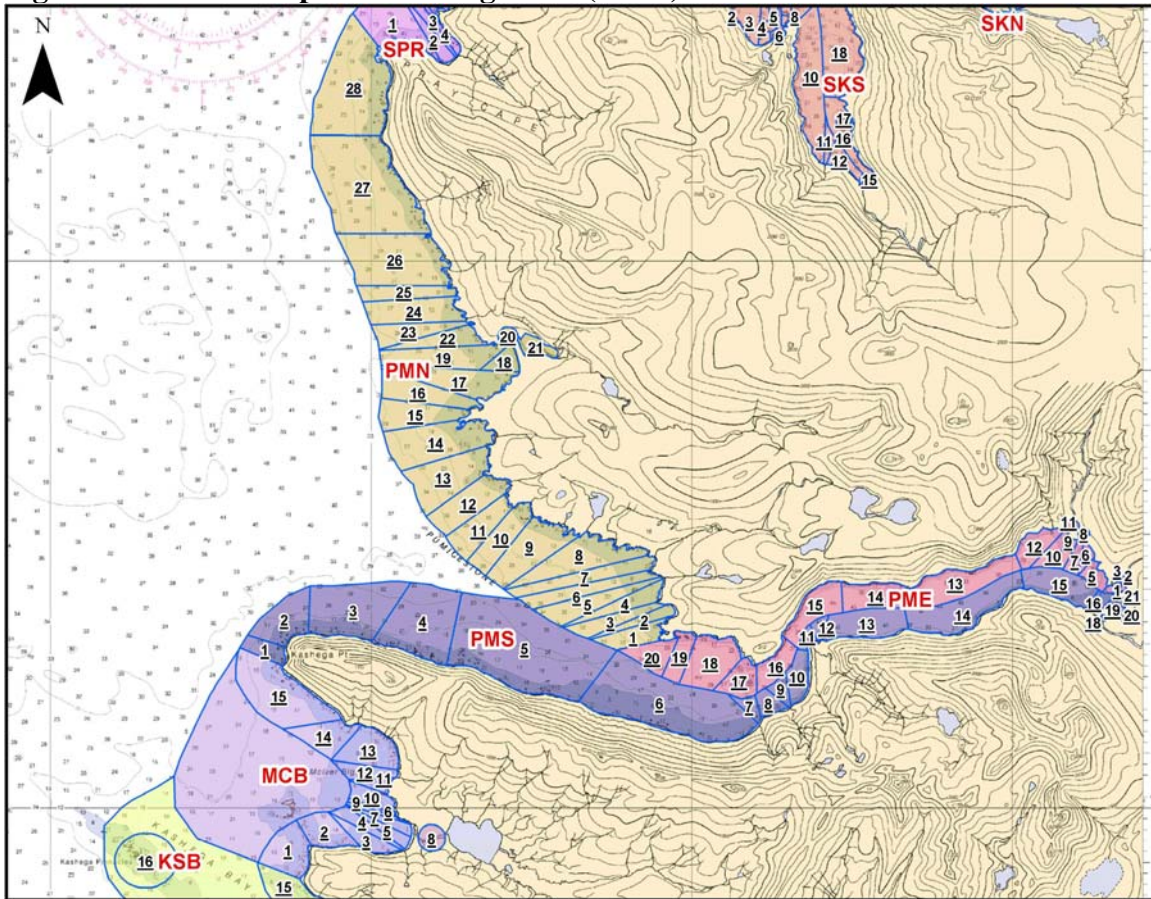
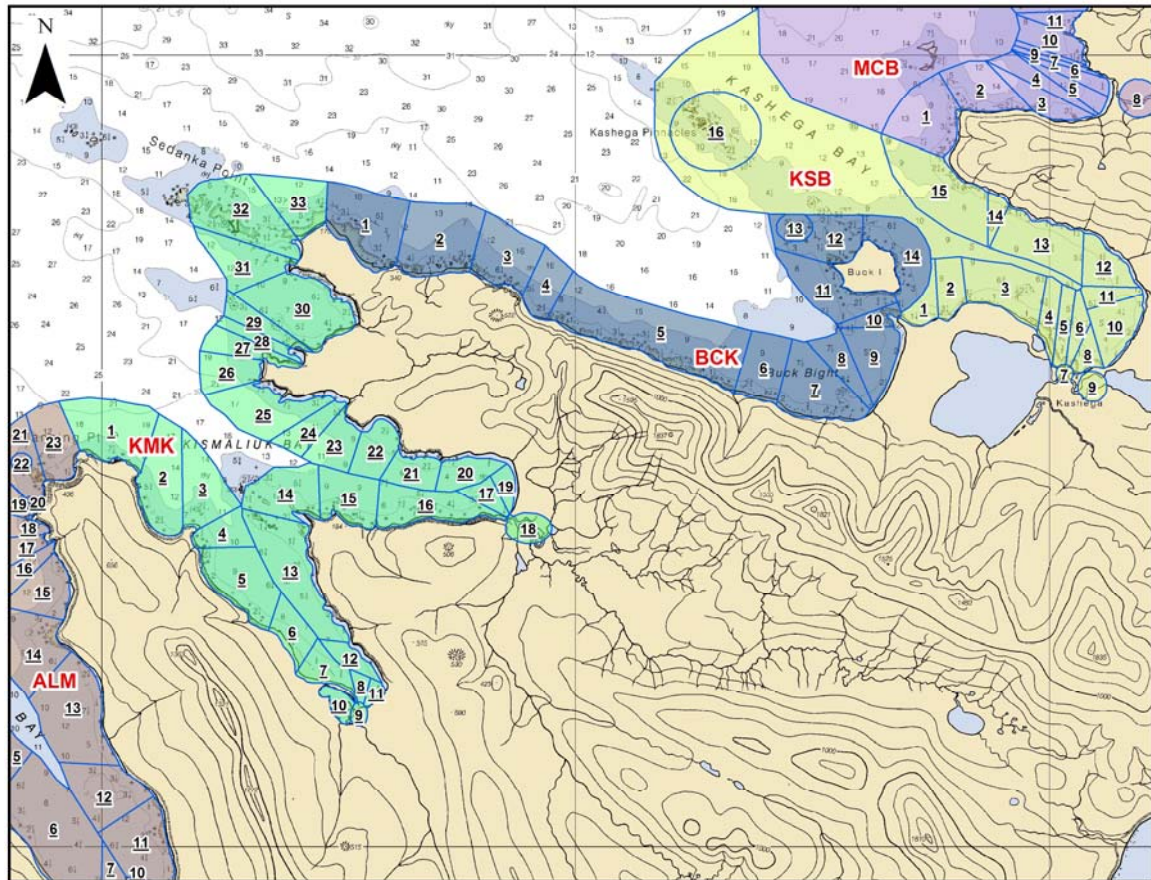
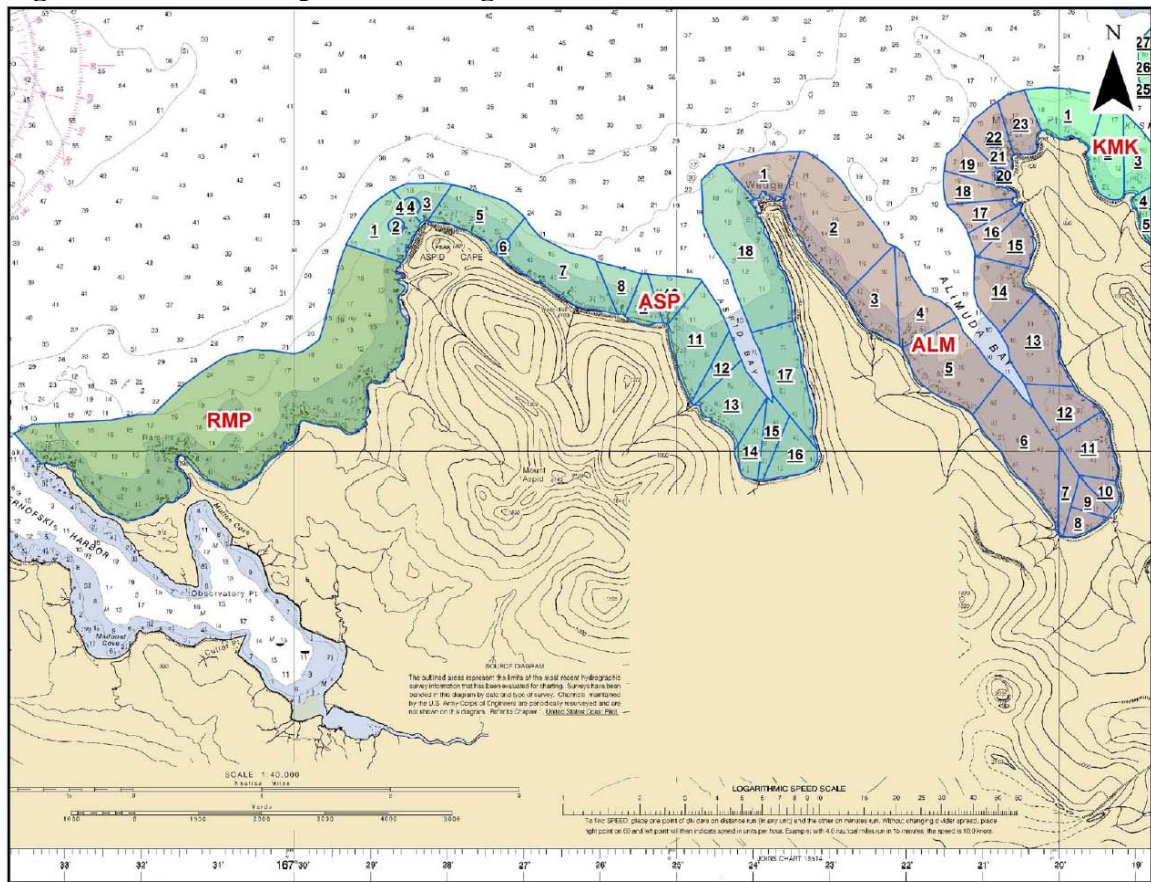
Figure 2. Detailed map of SCAT segments (1 of 6)

The Unified Command for the *Selendang Ayu* oil spill divided the 469 miles of shoreline in the potentially spill-affected area into 806 segments (Figure 2). Of these, 123 segments (70 miles) received enough oil somewhere in the segment to require oil clean-up treatment. The sum total of the length of oiled shoreline within all these segments was over 20 miles. One hundred and two of the oiled segments were actually approved for clean-up operations. Primarily because of safety concerns for the cleanup personnel, the remaining 21 segments were not treated.

Methods: NOAA pre-assessment teams conducted field surveys of the spill area on-foot from 27 December 2004 through 1 February 2005, in addition to observations made by Rapid Assessment Technique (RAT) and Shoreline Cleanup Assessment Technique (SCAT) teams. NOAA personnel participating in the pre-assessment field surveys were: Lisa DiPinto, Nick Iadanza, John Cubit, Doug Helton, Ian Zelo, and Daniel Hahn, with assistance from Danielle Savarese (Stratus Consulting). Janis Krukoff and Laresa Syverson (both with Qawalangin Tribe) and USFWS personnel also participated in these surveys. The USFWS vessel M/V *Tiglux* was used as a working platform. Landing on beaches was accomplished using skiffs. The selection of shoreline segments surveyed was determined by the USFWS sampling plan used to survey the segments for bird carcasses. This was a stratified-random design, with the strata being wave-exposed, wave-protected, and accumulation beaches. Segments were randomly selected within these strata. Segment identification codes were the same as was designated for SCAT surveys and is shown in Figure 2.

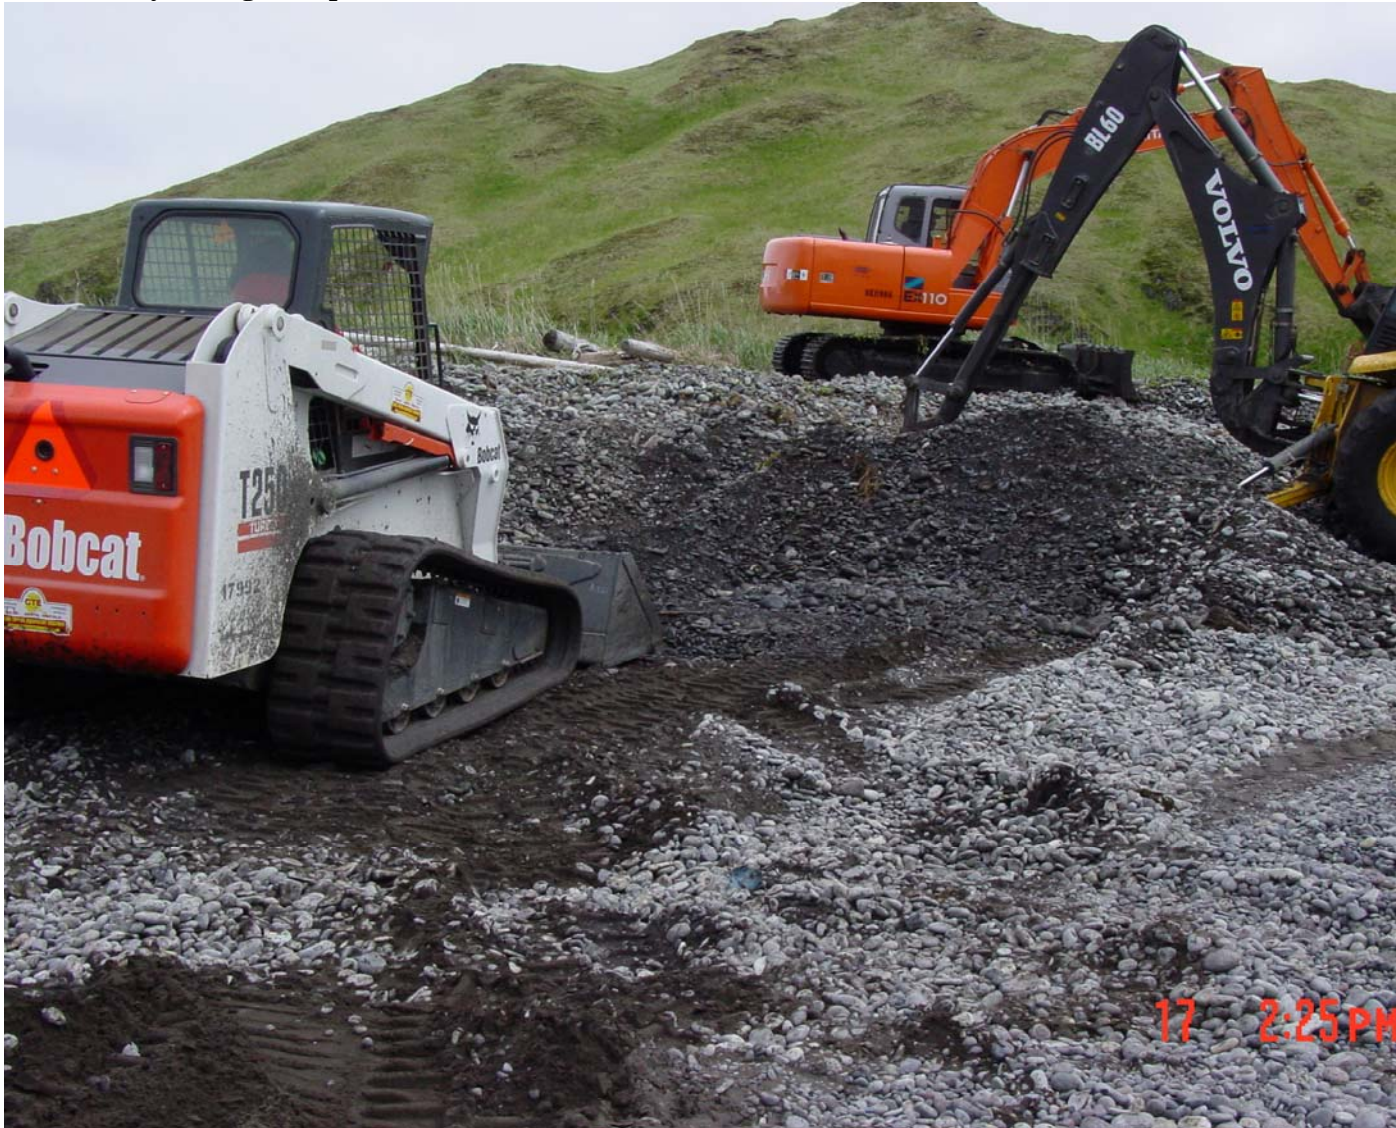
Photo of Dry Tilling to Expose Buried Oil at HMP-12 (2 December 2005)

The stream at HMP-12 was examined on 20 June 2005, when clean-up crews were working on a deposit of oil from the adjacent beach at HMP-11b. The high intertidal area at HMP-12 had been tilled to expose the buried oil to removal by natural factors after bulk removal of oil deposits by hand, which includes remobilization by wave action, according to information posted on the Unified Command website (http://www.dec.state.ak.us/spar/perp/response/sum_fy05/041207201/041207201_index.htm). Oil-stained rocks and tar balls mixed with sediment were found along portions of the stream bank, where Iadanza reported 100% cover of oil on stream banks on the lower 100m of stream during a 19 January 2005 site visit. In the second trip to HMP-12 (23 June 2005), a 60% cover of oil was observed deposited on a gravel berm adjacent to the salmonid stream at a distance of 80 - 100m from the stream mouth. On both visits to HMP-12 (20 and 23 June 2005), oil sheen was seen in the intertidal areas of the beach on both sides of the stream mouth, below the location where beach materials had been redistributed. There was oiled wrack near the stream mouth and oil-stained rocks in the stream mouth.
